FORMER TOKANUI PSYCHIATRIC HOSPITAL  
DEMOLITION AND REMEDIATION  
EXISTING DISPOSAL SITES – INTRUSIVE INVESTIGATION REPORT

146 TE MAWHAI ROAD  
FORMER TOKANUI PSYCHIATRIC  
HOSPITAL, TE AWAMUTU

Project No.	33097	Approved for Issue	
Version No.	3	Name	Sean Finnigan
Status	Final	Signature	 
Authors	E Bish, T Bohles, S Finnigan		
Reviewer	S Finnigan	Date	26/06/2024

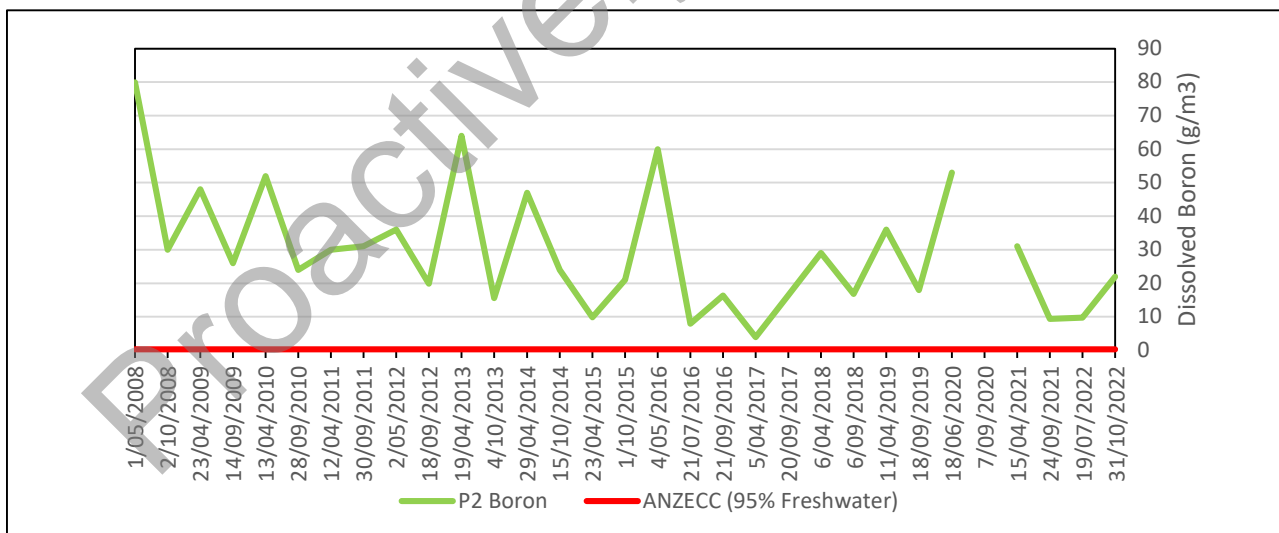
Long term monitoring data appears to show that boron is leaching from the landfill into the stream, being consistently present at elevated levels in the groundwater in one monitoring bore (refer Figure 5). All stream samples have recorded boron levels below the ANZECC freshwater guidelines for protection of 95% aquatic species, but the monitoring data shows that boron levels are consistently higher downstream of the landfill, with some data indicating boron leaching may primarily be coming from landfill areas A, B or C (refer Figure 6).

**Figure 5: Long term dissolved boron levels (g/m<sup>3</sup>) in shallow groundwater from monitoring well P2**

The likely source is coal ash, which is understood to have been used as a cover material in some landfilling areas.

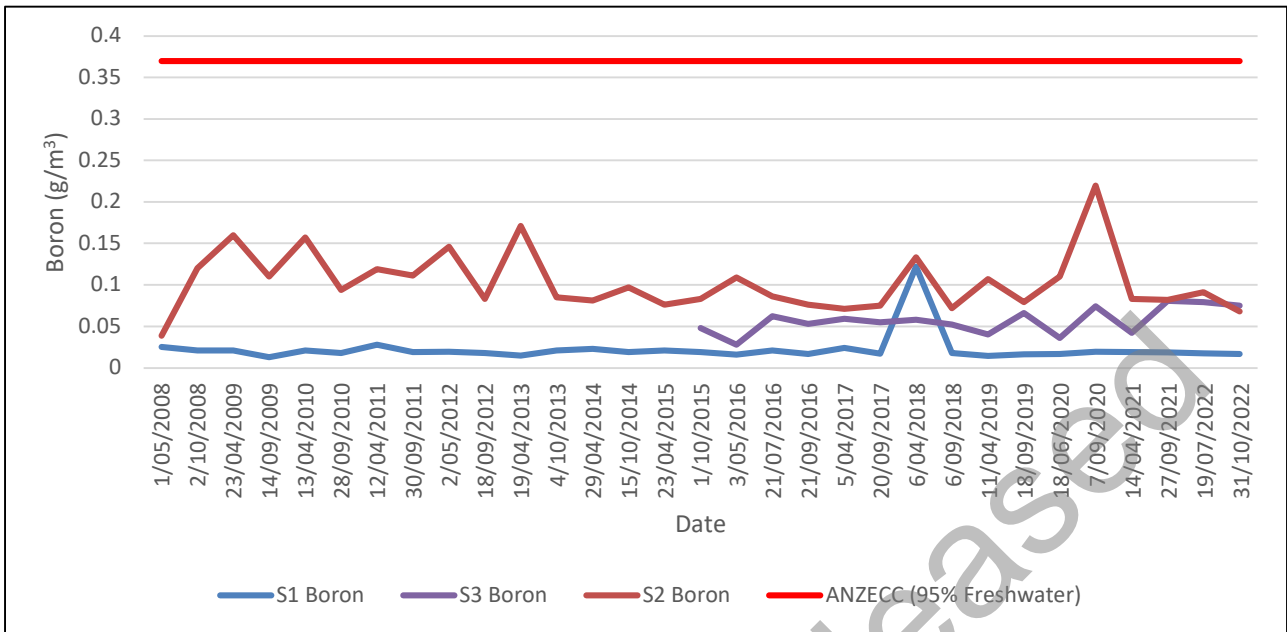
Figure 6: Long term boron levels (g/m<sup>3</sup>) upstream (S1), midstream (S3), and downstream (S2) of the landfill in comparison to ANZECC 95% protection trigger value for aquatic species. See Figure 7 for sampling locations

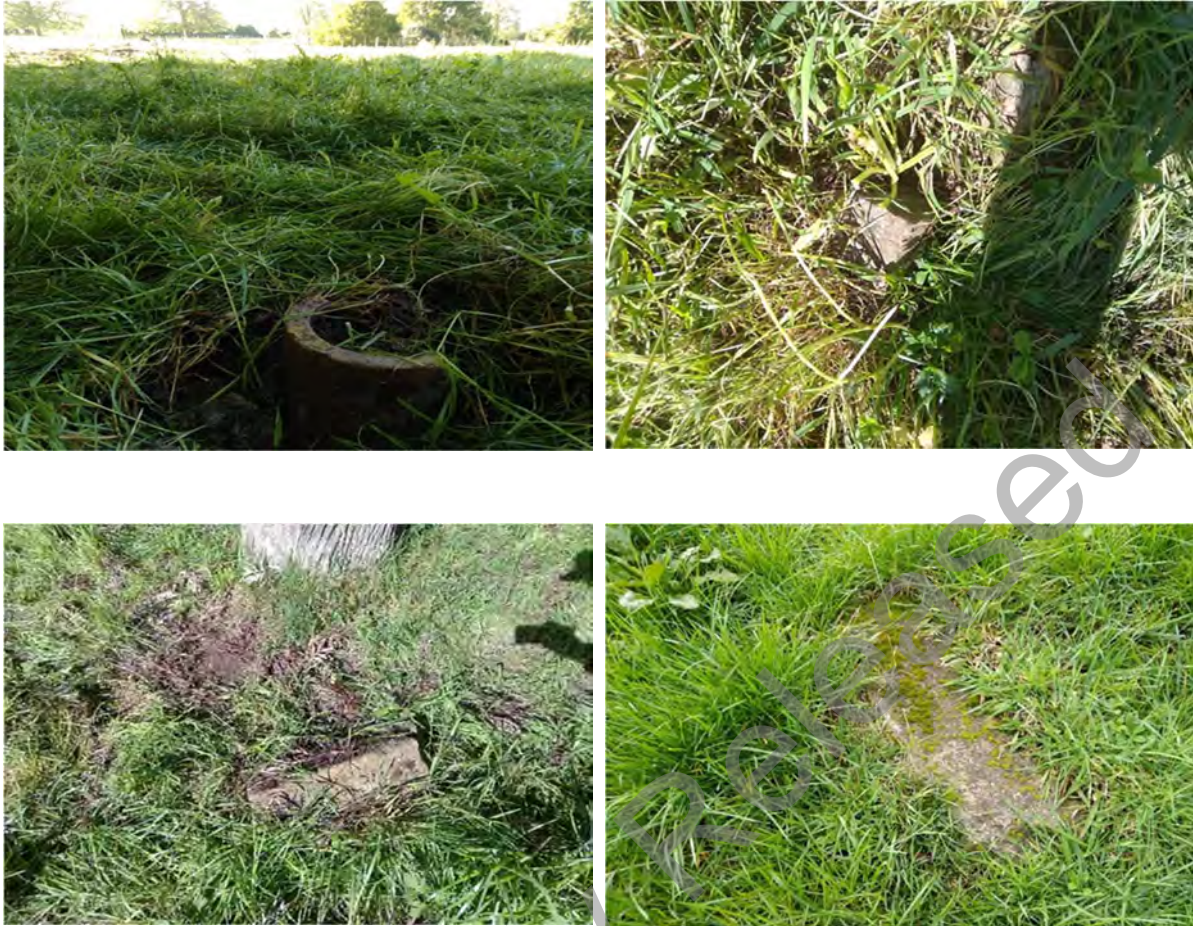
During the 2022 annual walkover survey (refer separate report for details and Appendix B for grid walkover findings), it was found that there were various instances of individual refuse items (e.g., wooden posts, planks, cement blocks) protruding through the landfill surface, consistently around the edges of the landfill areas (refer Figure 8, below). There was one area which showed small localised damage to the landfill cap of the landfill (refer Figure 9, below). These observations mainly apply to Areas A and D. They mean that the landfill cap has been breached in a number of locations. The protruding objects should be removed and the landfill cap reinstated.

**Figure 8: Refuse protrusion across the site (ceramic pipe (B3), wooden post (E4), brick (D4, concrete (D4)) – for grid references, refer Appendix B for grid locations**

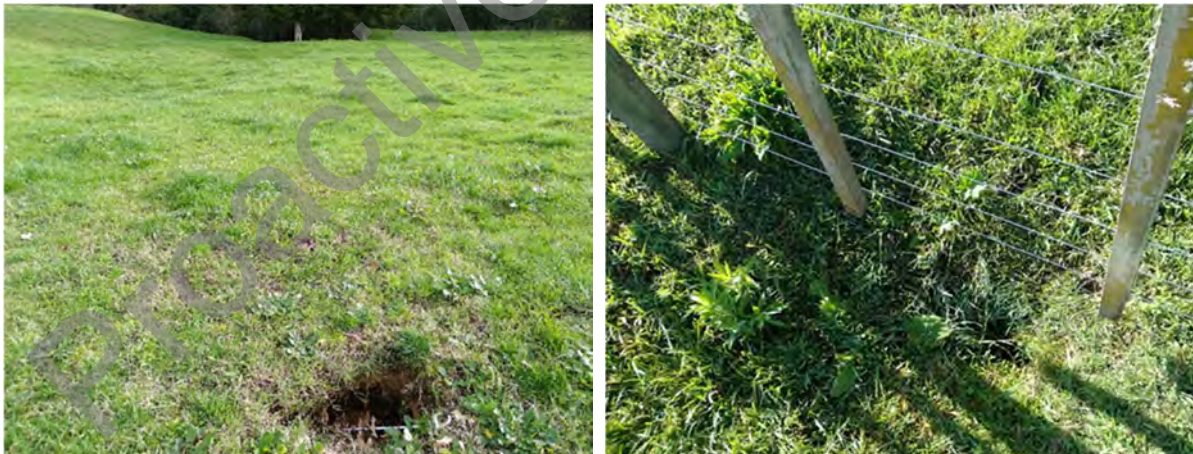
**Figure 9: Evidence of damage to landfill cap in Area E and at extent of Area A (Left N7, Right A3)**

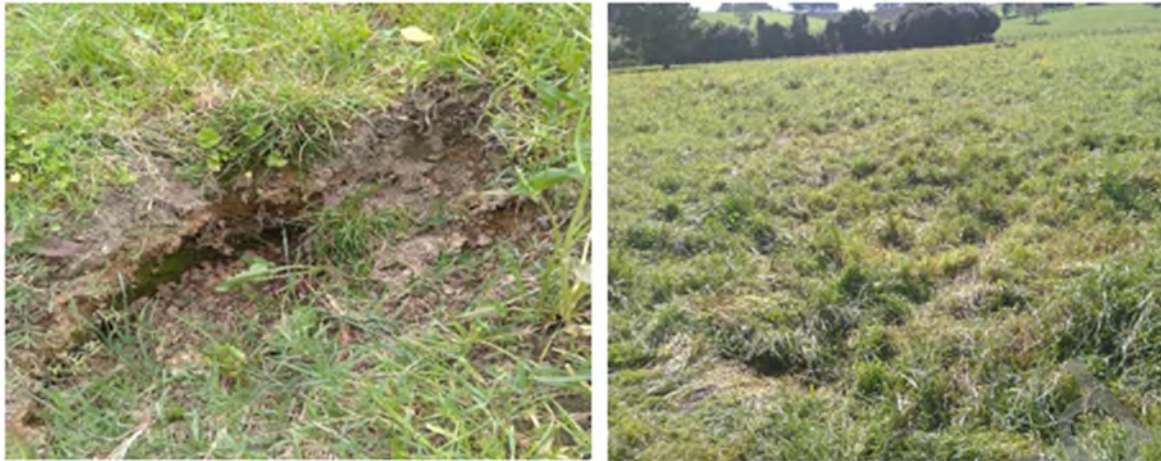
- Area D was observed as having very uneven topography including patches of settlement. Significant subsidence was observed at grid N7.
- Area E was primarily in good condition. The only feature of note was general sloping settlement of the land. Previous visits have noted ponding filling this settled area, but none was observed during 2022.

**Figure 10: Instances of subsidence visible on site at areas E and A respectively (Left N7, Right E4)**

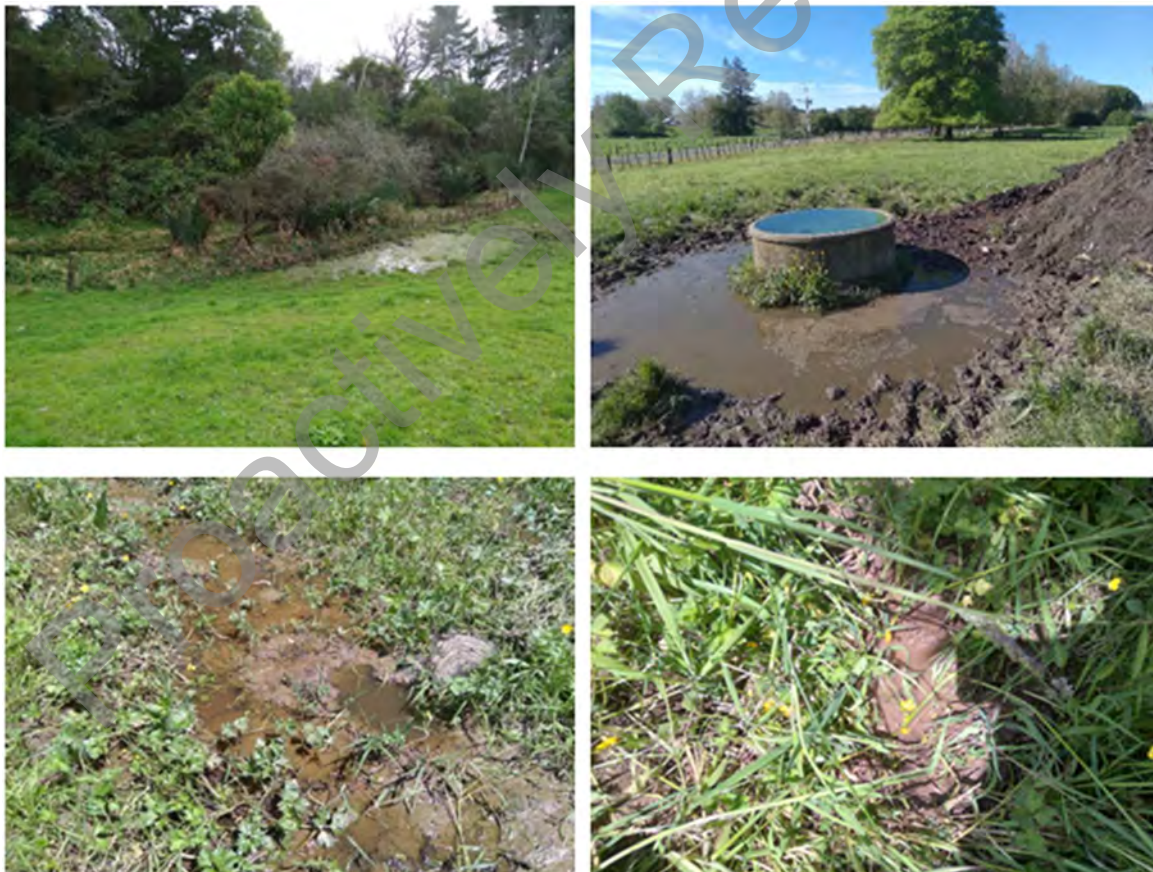
- In Area A, ponding was observed at Grid D7, surrounding a permanent water trough. Subsidence was visible at grid A3 at the fence line boundary.
- Area C was observed as having large portions of ponding and some visible settlement and subsidence. Significant ponding was observed at H4 and minor ponding at K5, both located between the extent of area C and the Wharekōrino stream. Ponding at both locations has been noted in previous years, and high stream flow is likely a large contributor. Localized settlement is observable at I5 at the extent of area near the fence line. Subsidence was noted at K6 at the north-eastern extent of area C.

As stated earlier, landfill settlement will occur over time as a result of refuse consolidation and decomposition, which can create ponding areas depending on the nature of the surface grading and particularly if differential settlement occurs. Refuse burning would have reduced the amount of settlement expected through waste decomposition. As the last landfilling areas was closed over 20 years ago, it is expected that most settlement would have occurred by now.

**Figure 11: Areas of ponding observed across the landfill site (Top Left H4, Top right D7, Bottom Left K4, Bottom Right I7)**

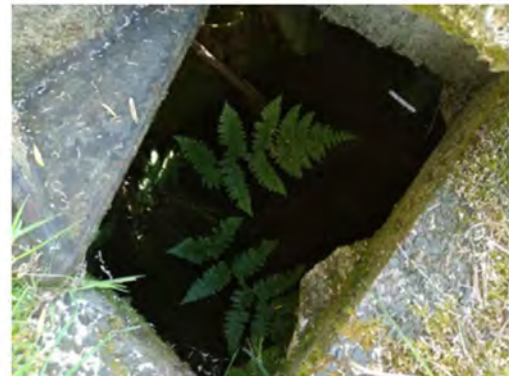
- The landfill areas can be classified as a “shallow” landfill, with LFG able to escape from it relatively easily through the landfill cap or laterally. The LFG will seek to escape from the landfill by the easiest pathway. The main components of LFG are methane, which can pose an explosion hazard, and carbon dioxide which can pose an asphyxiation hazard, while odour nuisance can also be a concern. Methane and carbon dioxide are both greenhouse gases. Lighter gases such as methane will tend to want to migrate upwards and where avenues exist, laterally. Hence, methane emissions in this case are most likely to occur through the landfill surface (e.g., cracks or through the cap itself) to the atmosphere. Heavier gases such as carbon dioxide tend to sink and can accumulate in depressions/cavities, of which only one structure was observed on-site in Area H, as shown below (Figure 12). This appears to be a redundant manhole chamber.

B1 – manhole

**Figure 12: Obsolete MH chamber in Area H**

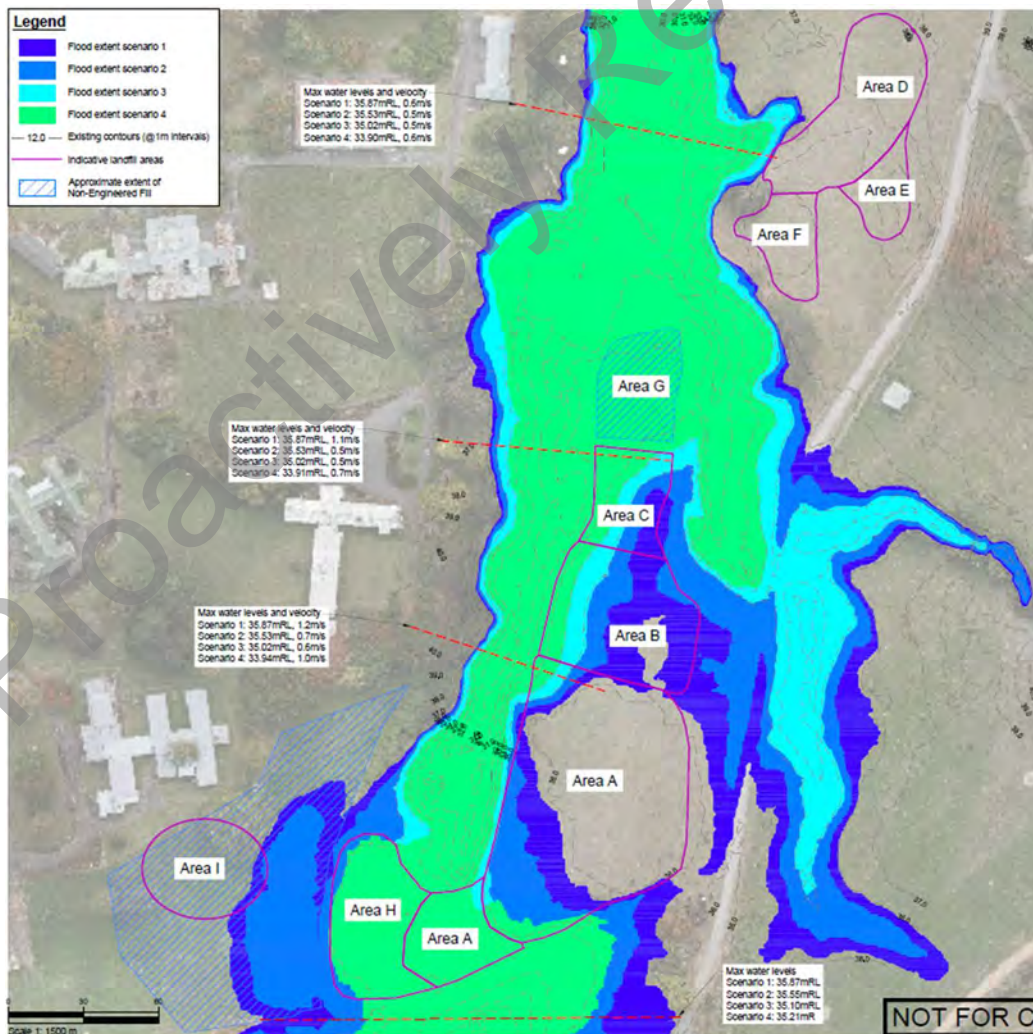
HEC-RAS modelling has been undertaken to assess this risk. This modelling has shown that the landfill areas A, B, C, G, H are currently likely to be inundated to varying extents during a 1% AEP storm event, particularly if the two downstream culverts on the stream are blocked or become blocked during the storm, with these effects worsening with predicted climate change. Areas D, E and F have been found unlikely to be affected by flooding. These results are shown in Figure 13, below.

**Figure 13: Flood Modelling Results:**
