***Appendix B***

***Landfill Annual (2022) Walkover Survey Findings***

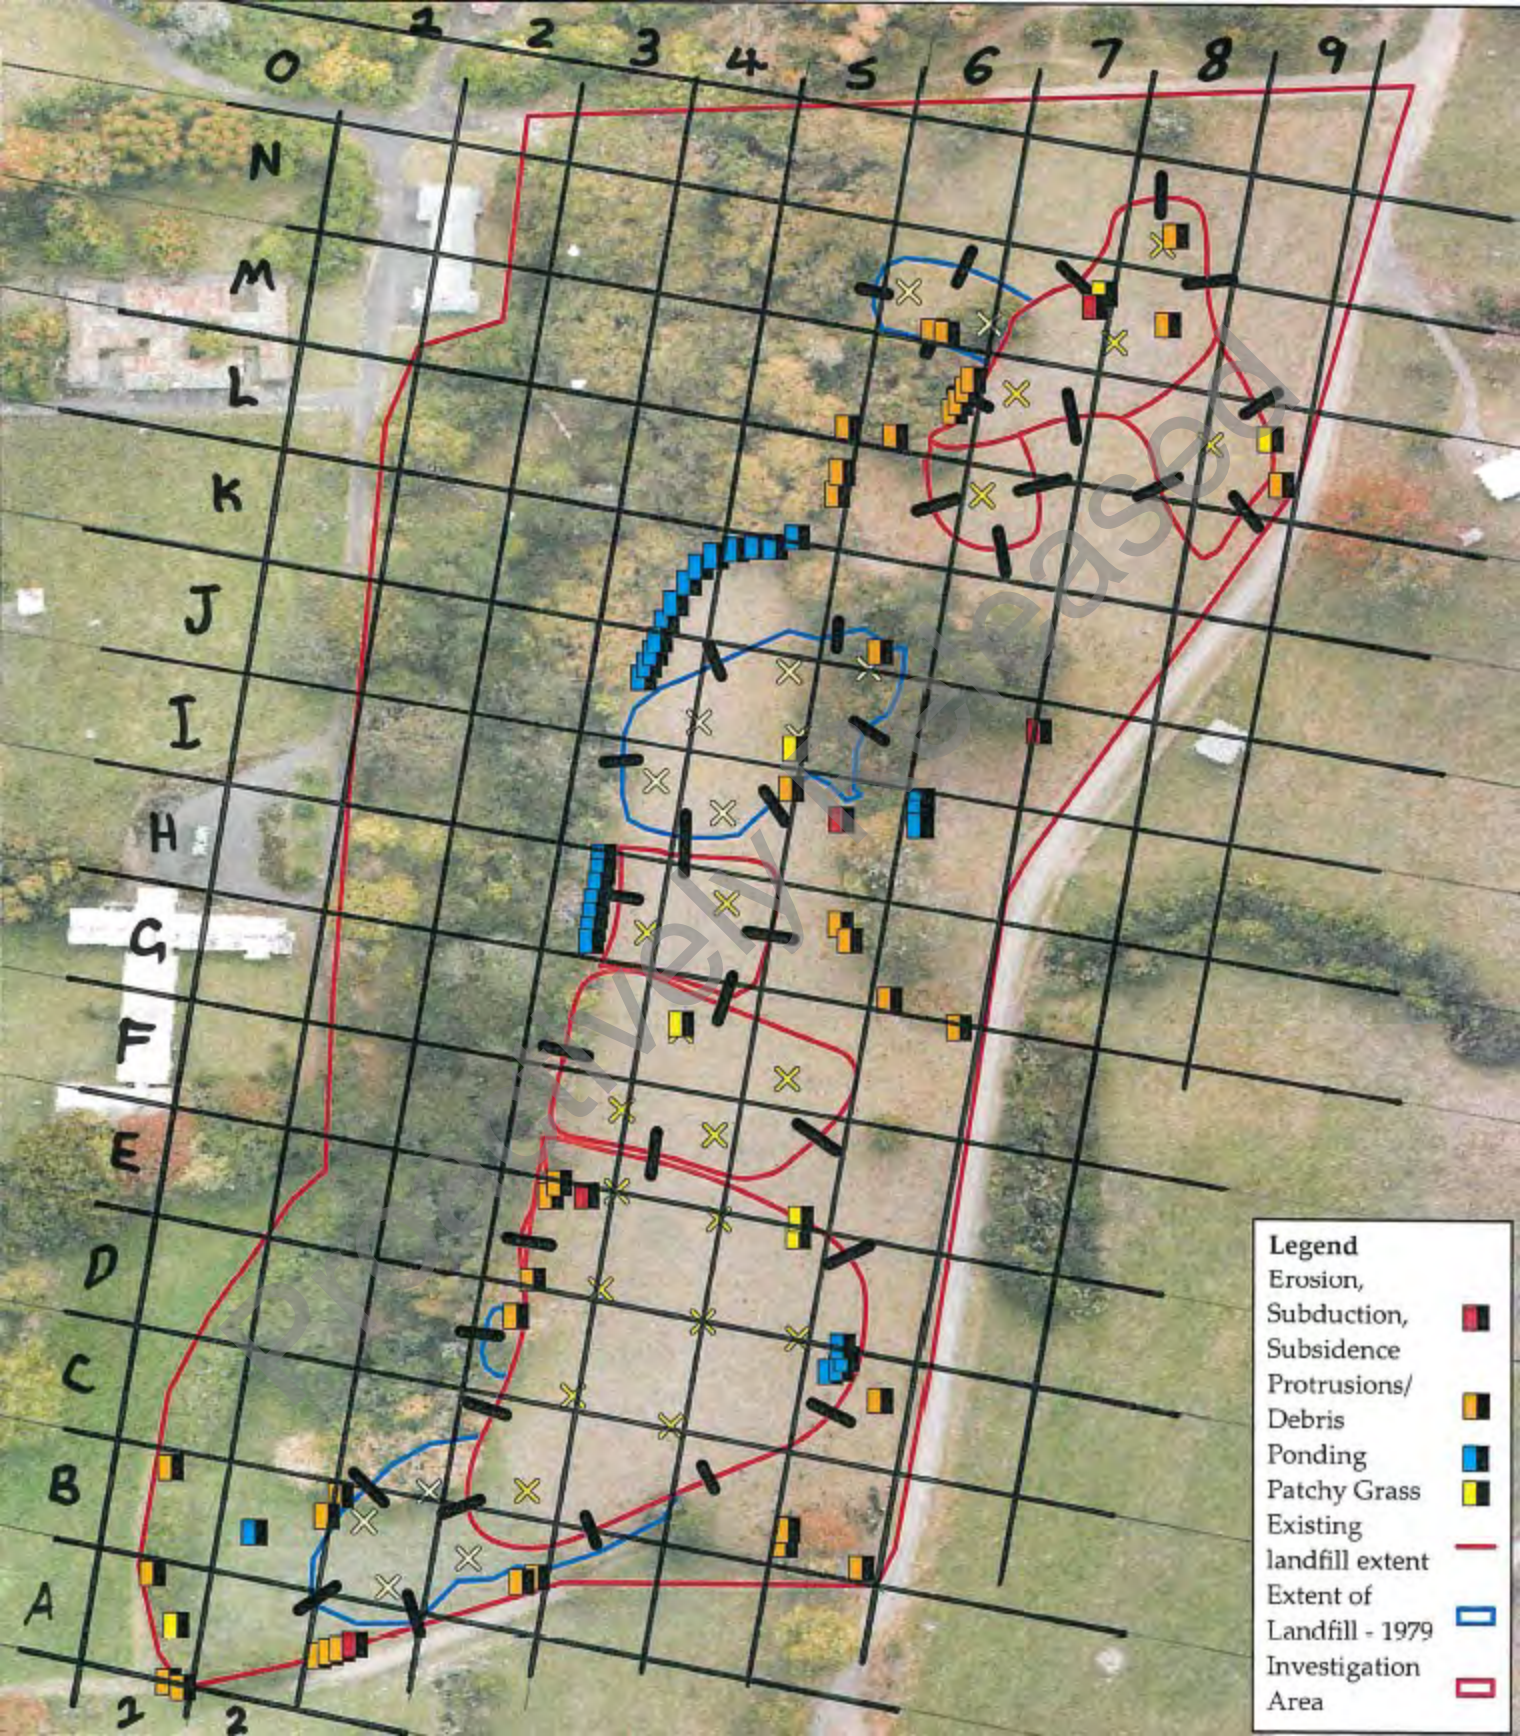
Landfill Area	Grid	Description – November 2022
-	A1	Patches of dead grass, cement and wooden post debris
-	A2	-
Extent of A	A3	Large concrete block, small subsidence/erosion near fence, cement protrusion

-	B1	Wooden planks, cement, cement piping debris, patchy grass growth
Extent of A	B2	Previous ponding – lily's growing
Extent of A	B3	2 ceramic pipes protruding
A	B4	Loose rock, brick, cement along fence boundary gully. Single cement block protruding

-	C1	-
-	C2	-
A	C4	-
A	C5	-
A	C6	-
-	C7	Mixed cement blocks, water trough?
A	D4	Concrete block protruding at surface
	D5	-
	D7	Trough, ponding
	E4	Subsidence – ground has sunken, wooden post protruding, rock/concrete protruding, patches of dying pasture, another sunken part, stumps protruding
	E5	
	E6	Patchy pasture
	E7	Patchy pasture
A & B	F4	-
	F5	-
	F6	Patchy pasture throughout

-	F7	
B	G4	
	G5	Patchy vegetation growth
	G6	-
-	G7	-
C	H4	Ponding at fence boundary
	H5	-
-	H6	Bricks, wooden post protruding
-	H7	Cement, wooden post protrusion
Extent of C	I4	-
	I5	Erosion, subduction at boundary fence

-	I7	Minor ponding
Extent of C	J4	-
	J5	Patchy pasture
	J6	-
-	J7	-
-	J8	erosion
-	K4	ponding
Extent of C	K5	ponding
	K6	Small subsidence
-	K7

-	K8	
-	L5	Concrete, ceramic protrusion
F	L6	
	L7	
E	L8	
D	M6	Rock, concrete blocks, scrap metal, metal piping, wooden posts
	M7	-
E	M8	-
	M9	Patchy pasture
D	N6	Brick, metal pipe protruding
	N7	Subsidence
	N8	
-	O5	-
-	O6	-
D	O8	Old stump protrusion
-	O9	-
-	P7, P8, P9	-

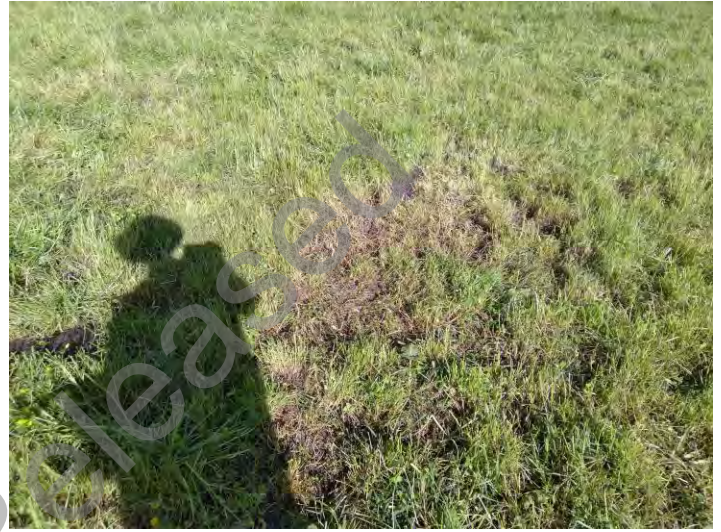
A1 – Patchy pasture

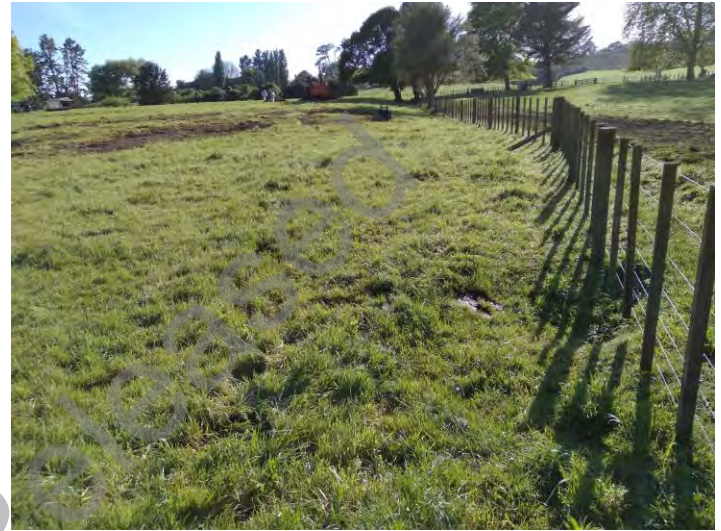
Ponding was observed at Grid D7, surrounding a permanent water trough. Subsidence/Erosion was visible at grid A3 at the fence line boundary.

A3 – large cement block

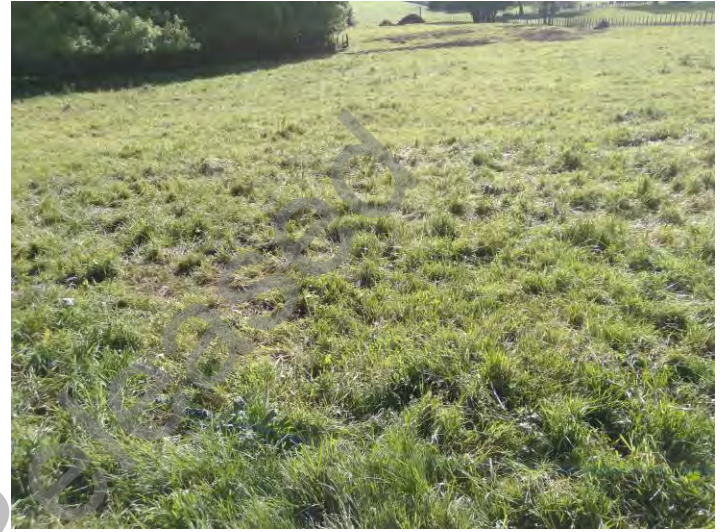
B1 – patchy pasture

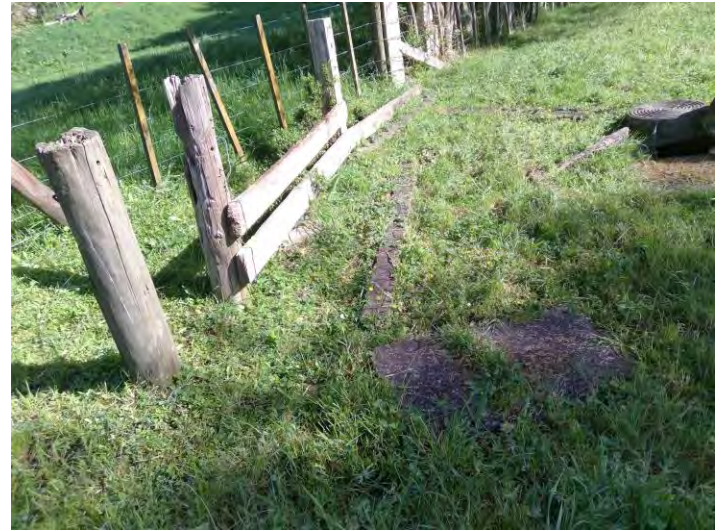
Protrusion of wooden posts and planks were visible at A1 and B1, which is reasonably far from the extent of the landfill in 1979, and at E4 at the edge of area A, which is more likely associated with filling activities. Cement blocks protrude at A1 and B1 which is reasonably far from the extent of Area A1 and likely dumped. They were also found protruding at A3, B4, D4, and E4 along the boundary fence line and western extent of Area A. 2 Ceramic posts were also noted to protrude at grid B3, at the extent of Area A.

B1 – cement blocks

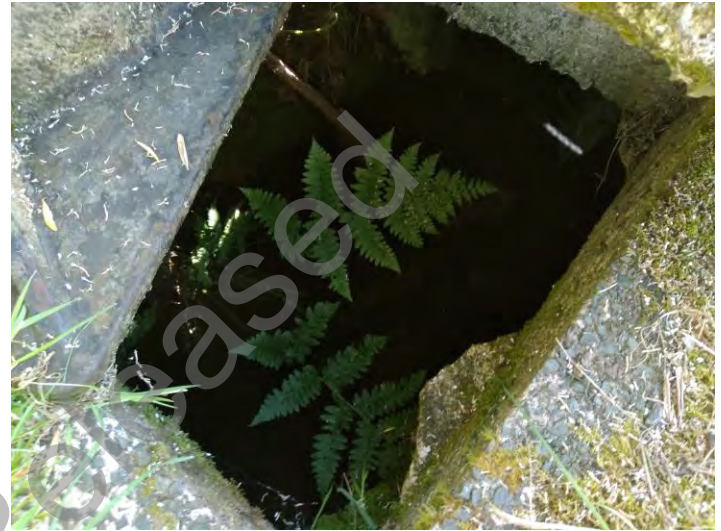
B1 – manhole

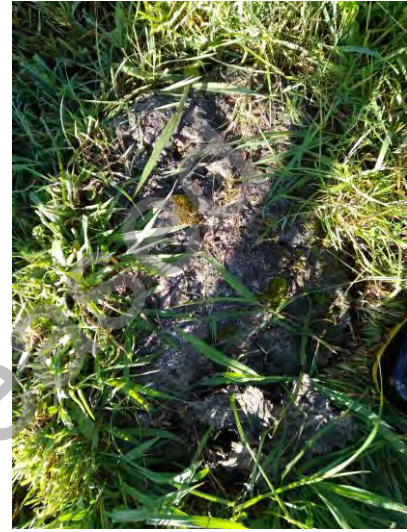
B4 – cement block protruding

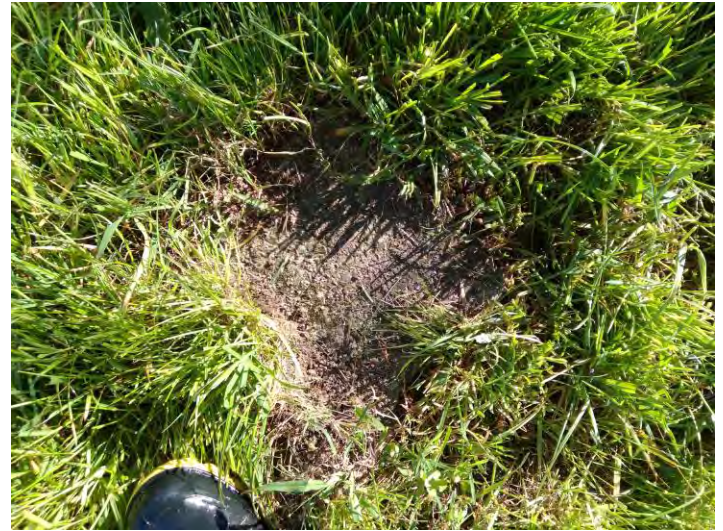
B4 – cement block protruding

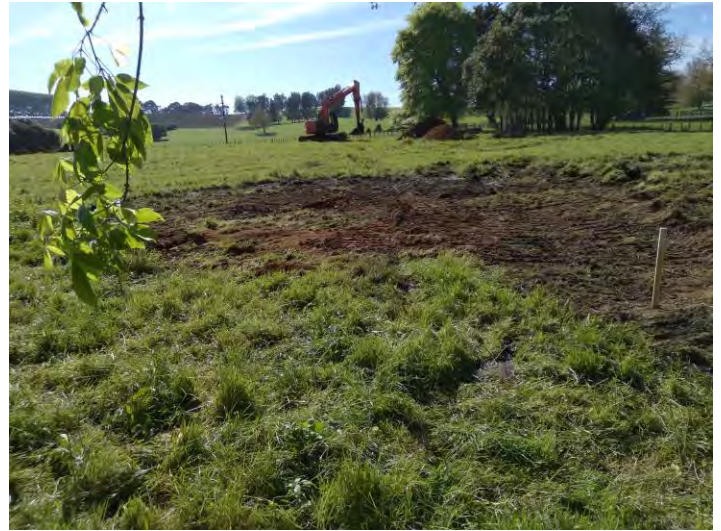
C7 – mixed cement blocks

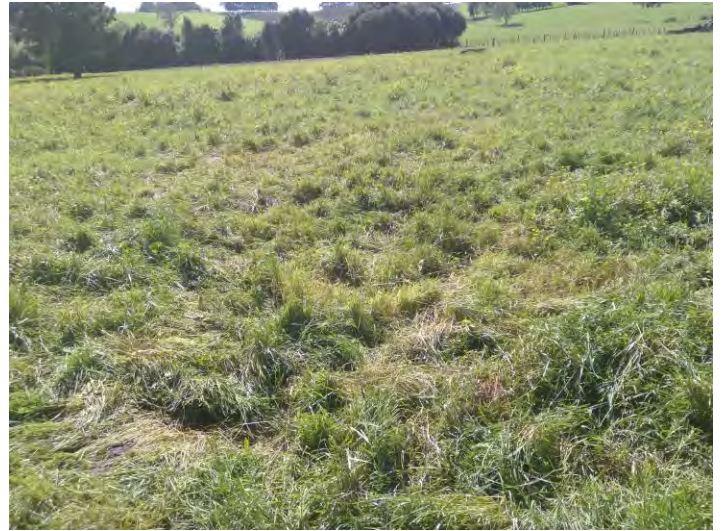
E4 – patchy pasture

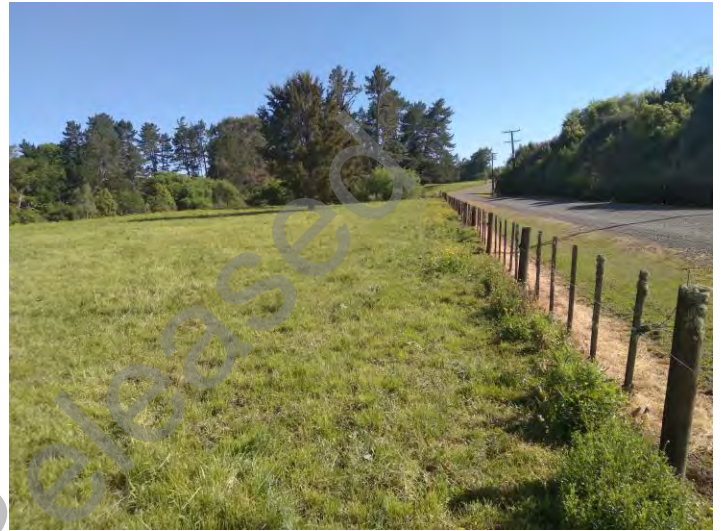
E7 – patchy pasture

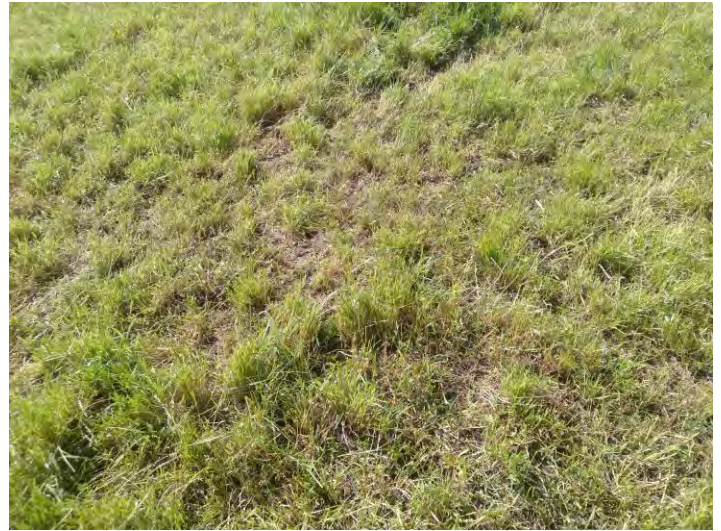
F6 – patchy pasture

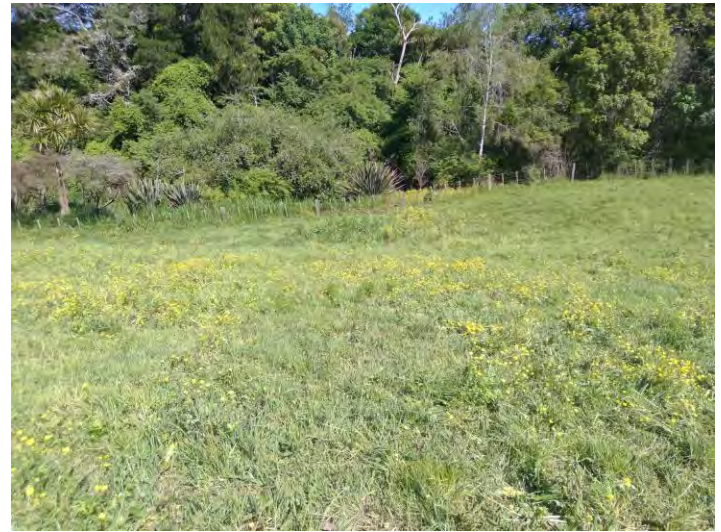
Area C: Area C was observed as mostly lush pasture, with large portions of ponding some visible subduction and subsidence. Grid J5 was the only portion of Area C where patchy pasture was observed, at the extent. Significant ponding was observed at H4 and minor ponding at K5, both located between the extent of area C and the Wharekorino stream. Ponding at both locations has been noted in previous years, and high stream flow is likely a large contributor. Localized subduction is observable at I5 at the extent of area near the fence line. Subsidence was noted at K6 at the north-eastern extent of area C.

H4 – Ponding at fence boundary

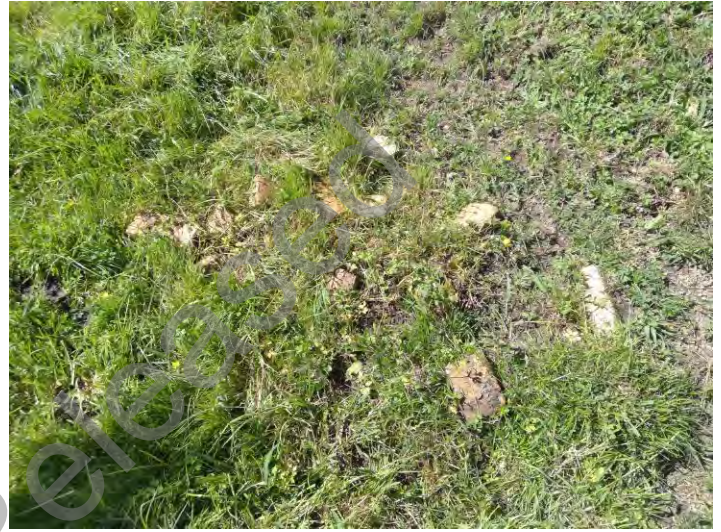
H6 – debris protruding

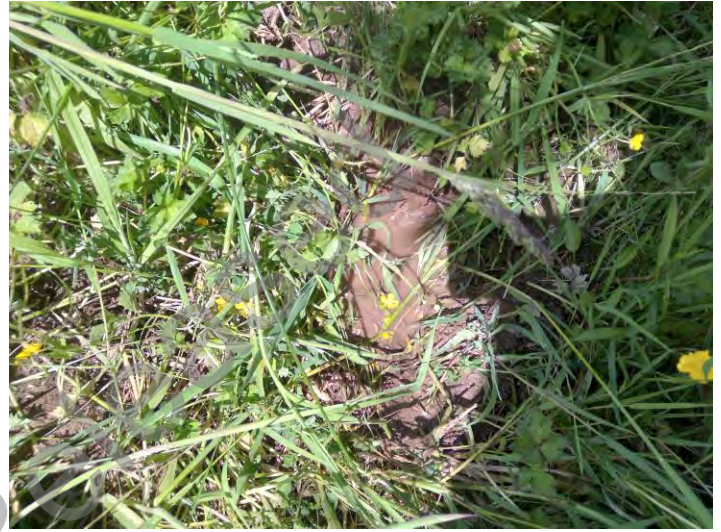
17 – minor ponding

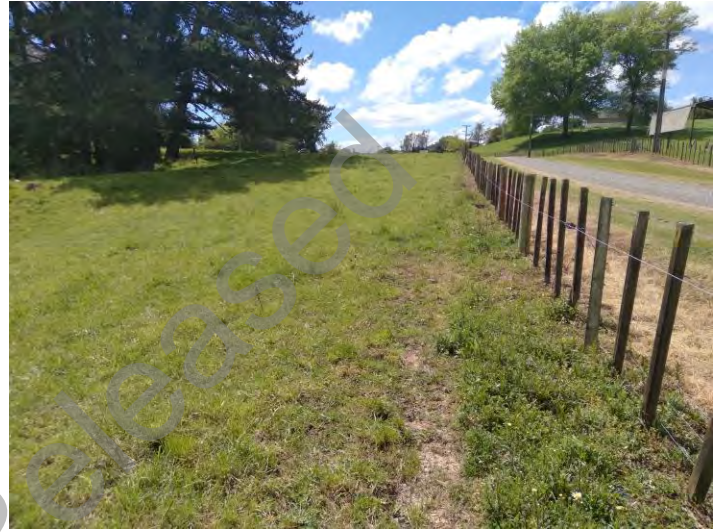
J8 - erosion

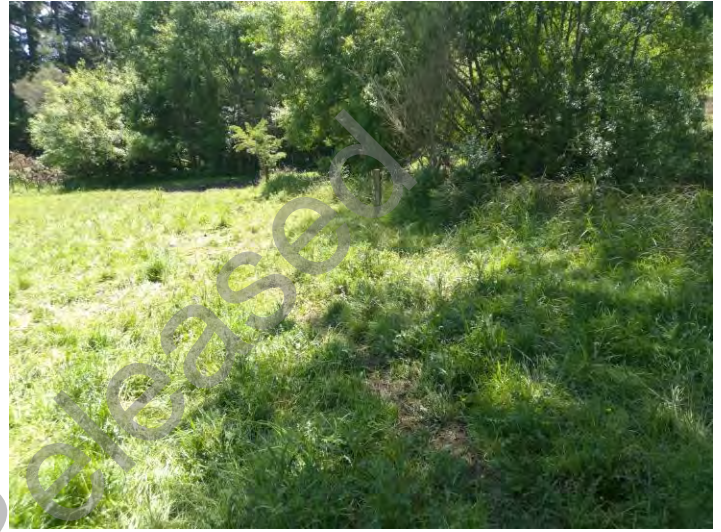
K4 - ponding

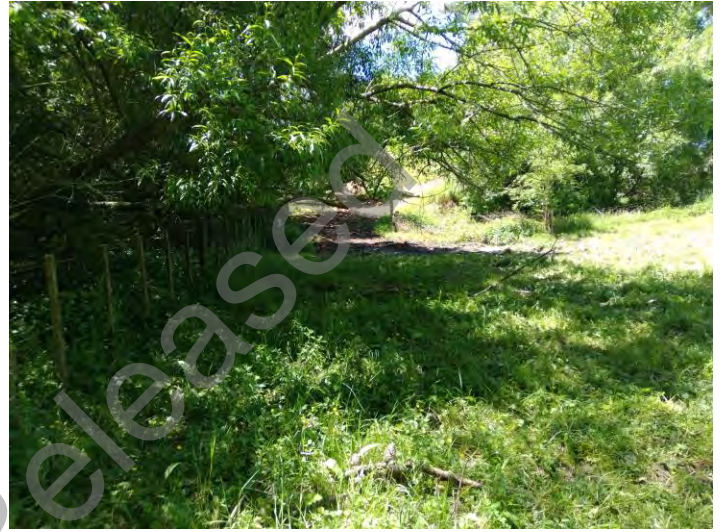
K5 - ponding

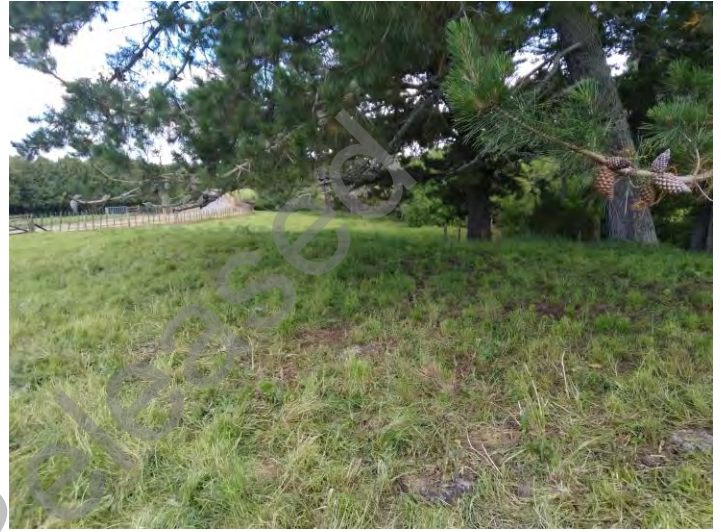
K6 – minor subsidence

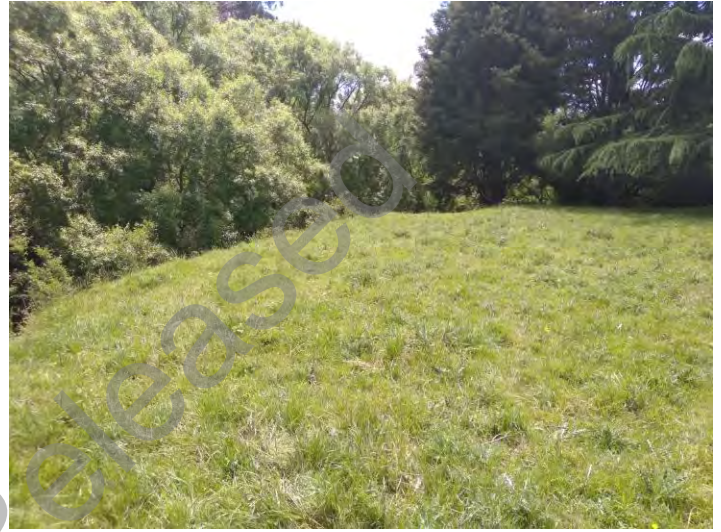
L5 – concrete protrusion
