GEOTECHNICAL INVESTIGATION

**STABILITY OF KITEWAO PUMP
STATION AND SURROUNDS**

**KITEWAO PUMP STATION AND
AWATAHA MARAE, NORTHCOTE**

Report Reference: 98191/1-E (Rev. 1)

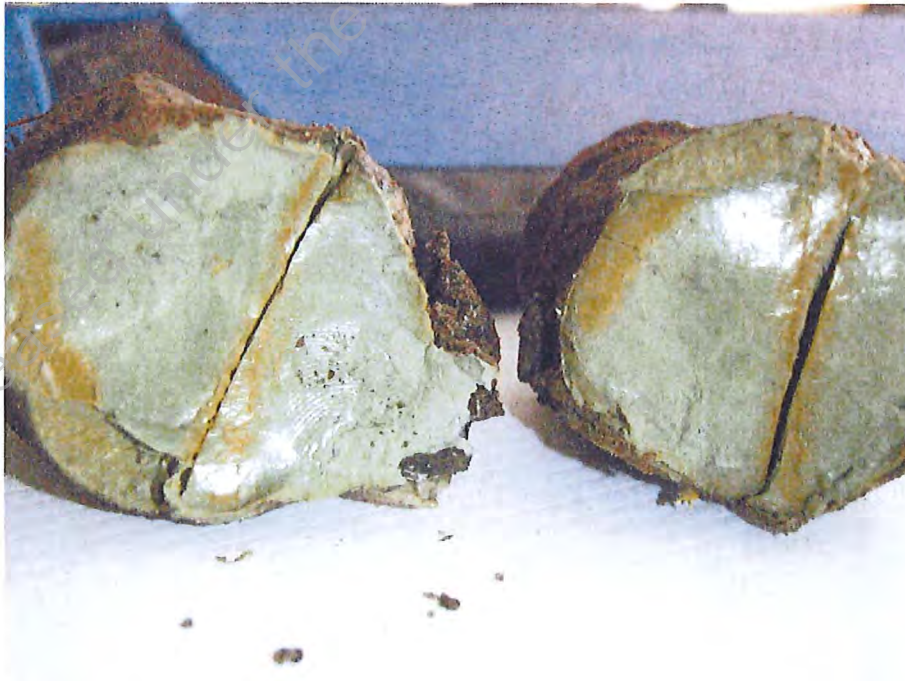
- A potential failure surface was encountered in MH3 at 8m in an SPT sample. The shiny surface and parallel striation marks indicate movement has likely occurred along this interface (Photo 1) at some time. The failure surface was also exposed in TP1, TP2 and TP3, extending to the base of all pits in the shape of a curve. The inferred failure surface profile is shown on attached cross sections (RILEY Dwgs: 98191/1-11 and 98191/1-12).

Photo 1: Polished surface and striation marks on core (MH3 8m depth)

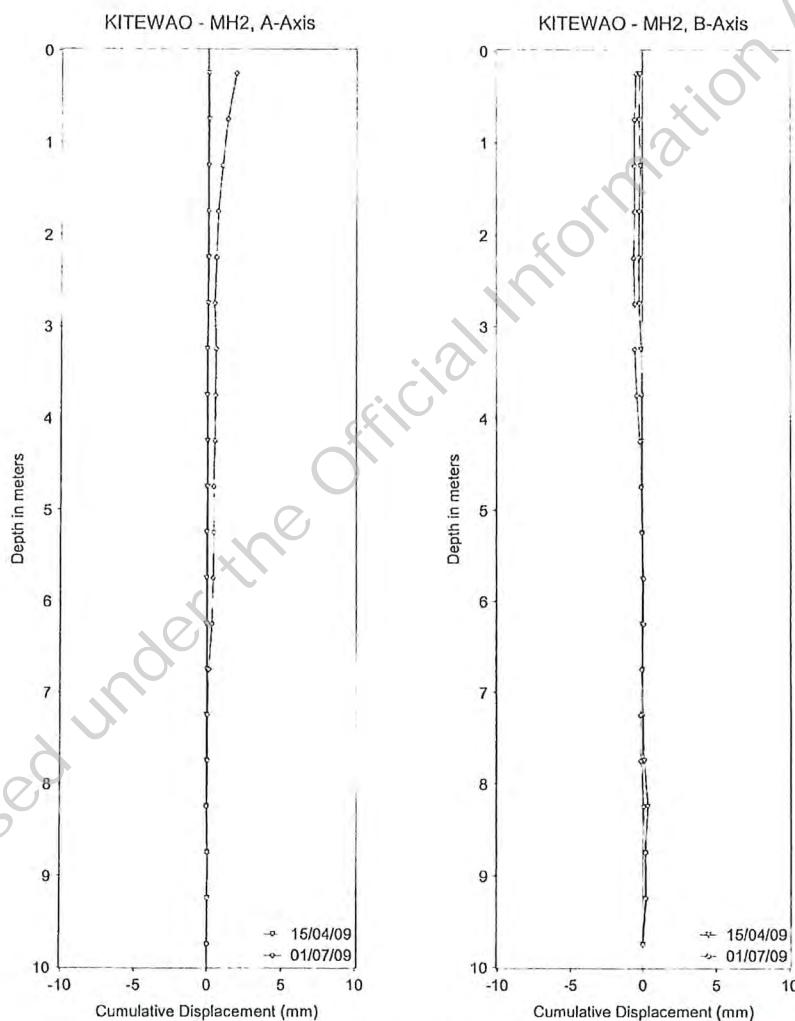
Since that time a further inclinometer survey was undertaken by Opus on 1 July 2009. This later survey detected some movement of the inclinometer tube downslope (Axis A), down to a depth of approximately 6.5m.

Figure 1: Inclinometer monitoring results up to 1 July 2009. Deflection is observed on the A axis, i.e. downslope to a depth of approximately 6.5m

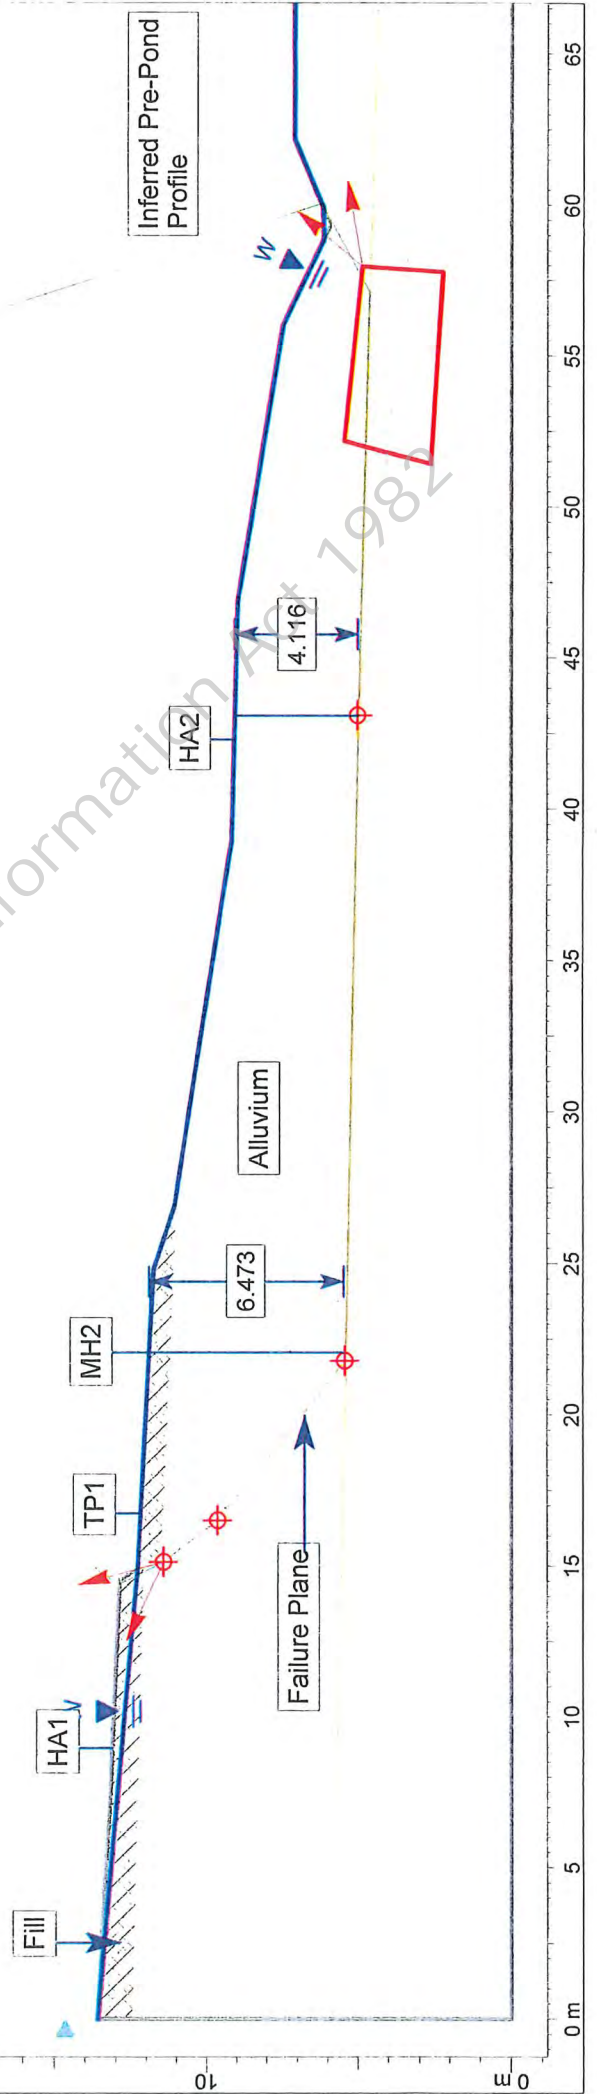
FoS=1.09

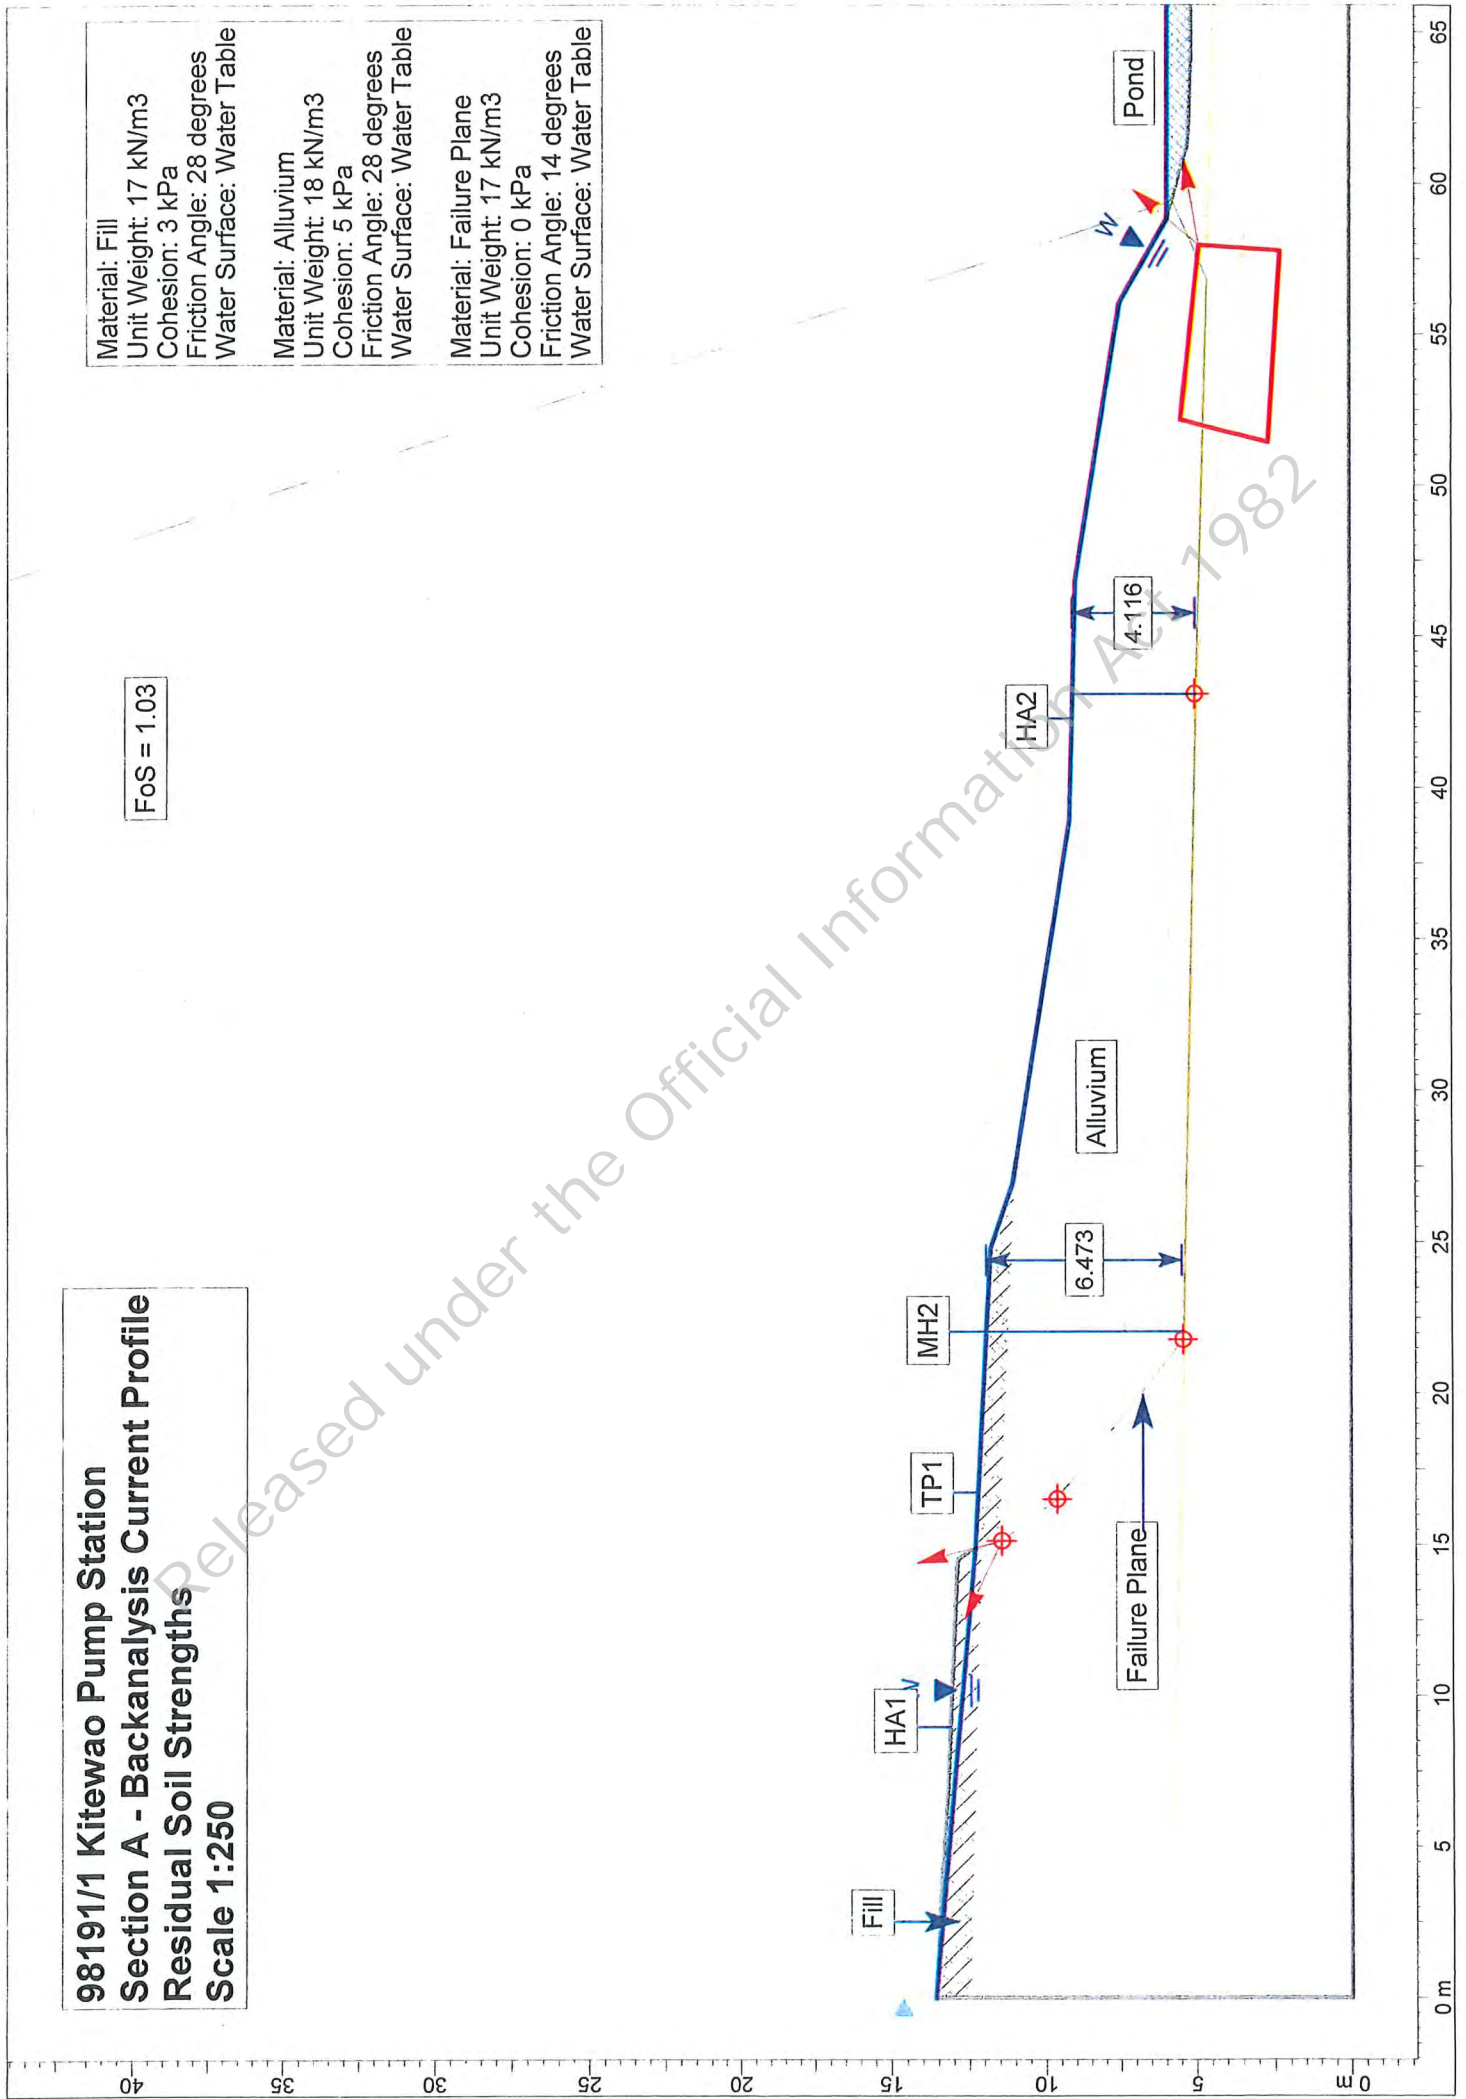
**98191/1 Kitewao Pump Station
Section A - Backanalysis Current Profile
Residual Soil Strengths
Scale 1:250**

FoS = 1.03

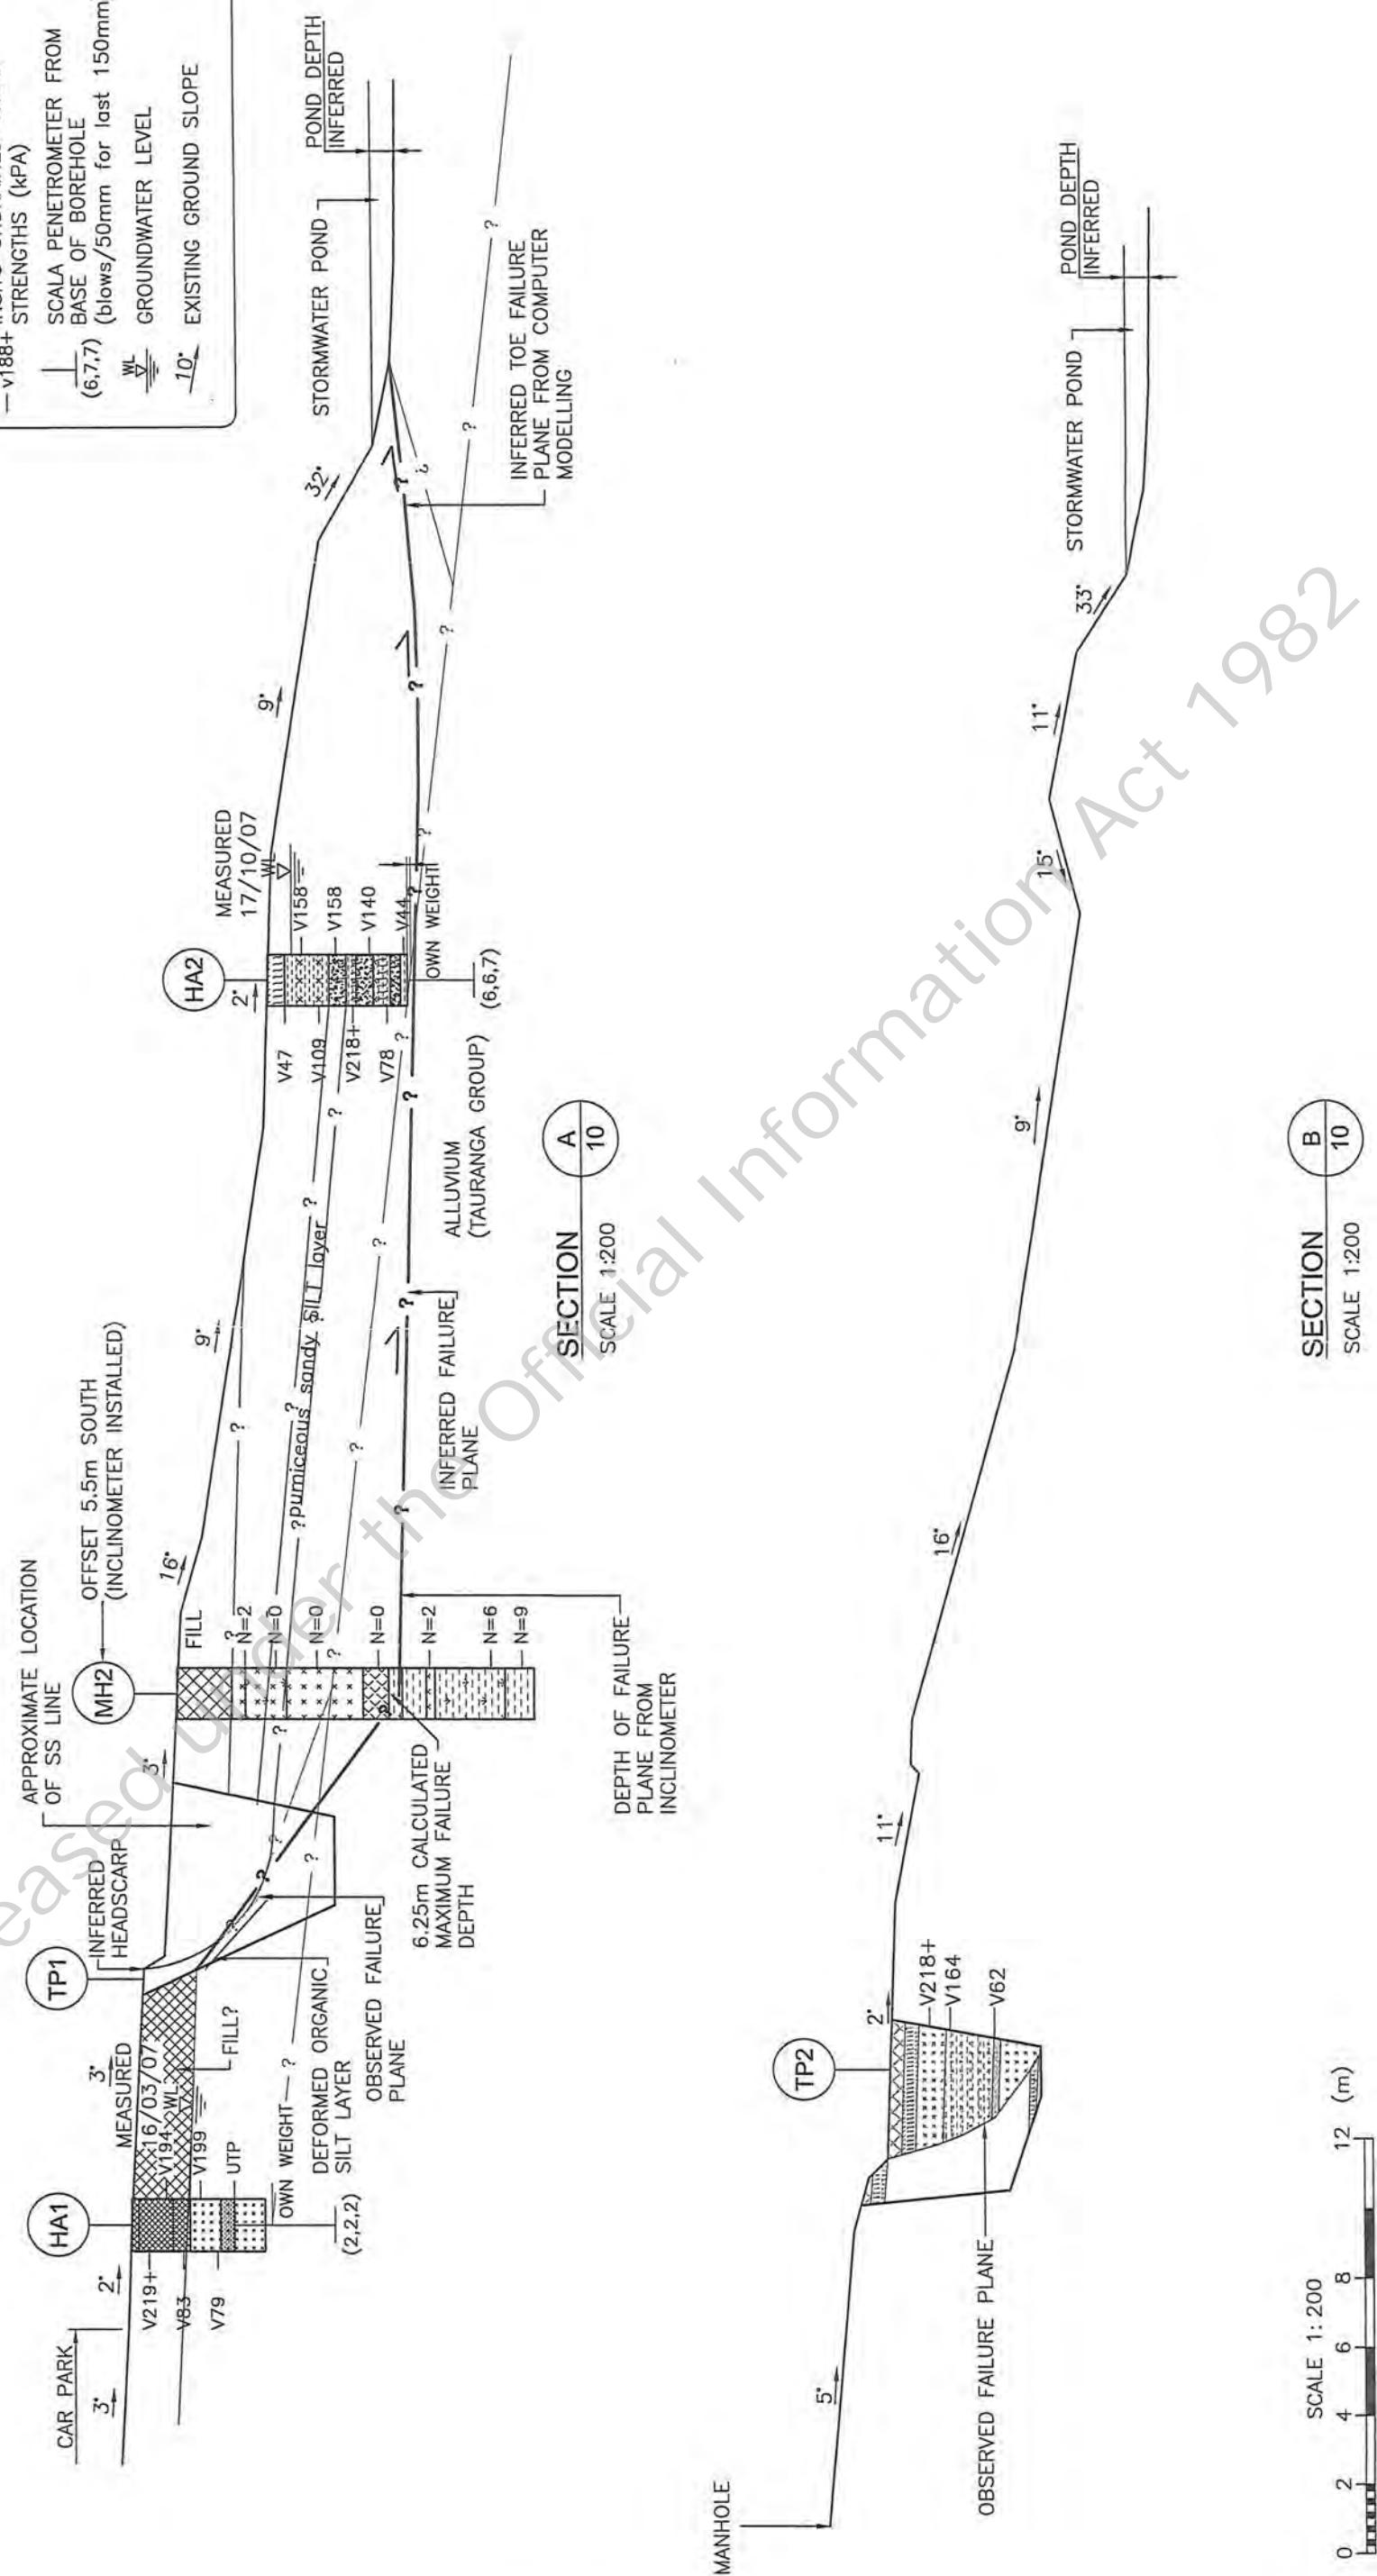
SECTION A
SCALE 1:200

On all cross sections the inferred failure surface is relatively flat, e.g. on section A (RILEY Dwg: 98191/1-11) the basal failure plane is inclined at 3° to 4° downslope. For failure to be occurring on such a flat surface, in addition to a relatively gentle slope, the soil strength parameters along the failure plane are likely to be extremely low. However, the flat nature of the failure plane likely restricts the movement to slow creep. Such a flat surface will be highly sensitive to groundwater pressures, thus a moderate reduction in groundwater pressures will likely result in a significant increase in stability.

Analyses have been undertaken along section A (RILEY Dwg: 98191/1-11) through the area of noted recent movement. Similar analyses were undertaken in 2007; however, the model has been updated with the latest subsurface investigation, with the most significant difference being a remodelling of the inferred failure plane, which is flatter than previously modelled.
