Appendix C
Geotechnical Factual Report

Project No. 65547

FORMER TOKANUI HOSPITAL CLOSED LANDFILL, TOKANUI – GEOTECHNICAL FACTUAL REPORT

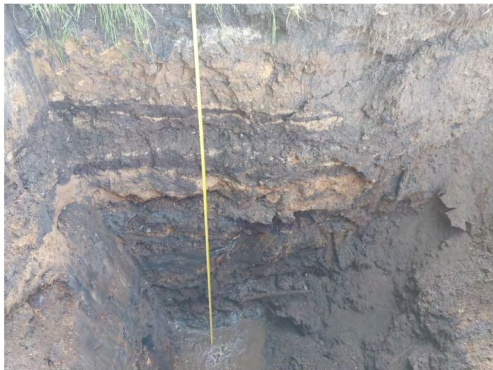
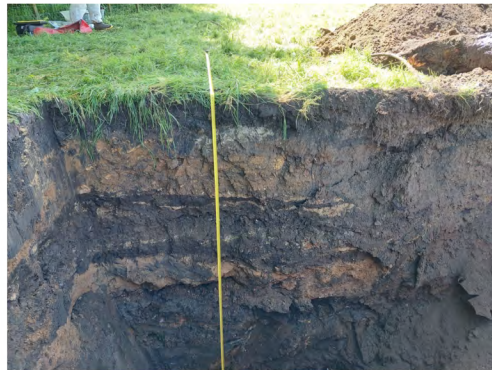
1.0	[LANDFILL] SILT, some sand (fine to coarse), black mottled orange/grey, stiff, moist, slightly plastic, contains abundant (20%) general refuse and construction debris including metal, concrete wood and bottles	Fill				64 (28)

2.8	becomes wet (leachate), minor pit collapse occurring													
3.4	SILT, clayey, grey streak black, stiff, moist, slightly plastic [ALLUVIAL SEDIMENTS]	Tauranga Group				92 (43)

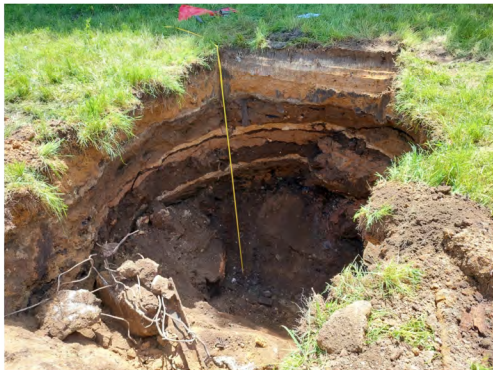
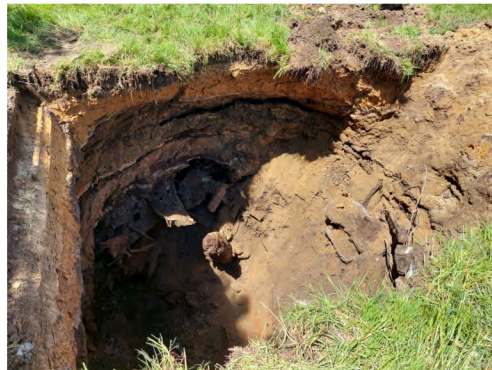
0.8	[LANDFILL] SILT, some sand (fine to coarse), brown mottled black/orange/grey, very stiff, moist, friable, contains abundant (20%) construction/building debris including asphalt, concrete, wood, brick, pipes and steel up to 1 m long 1.3 m - 1.5 m: CAPPING MATERIAL 2.0 m: contains 30% concrete beams and sheet metal present, trace general refuse including bottles 2.2 m - 2.4 m: CAPPING MATERIAL 2.6 m: 800 mm diameter steel tank 2.8 m: 2 m long log 3.5 m: becomes wet	Fill				0.8

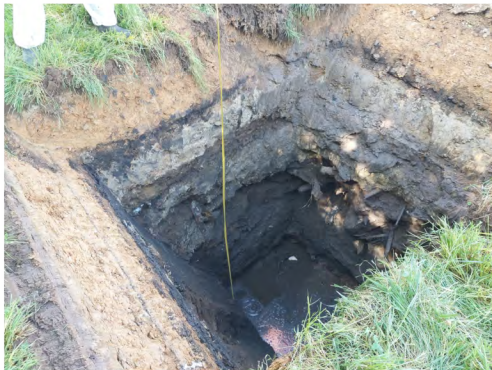
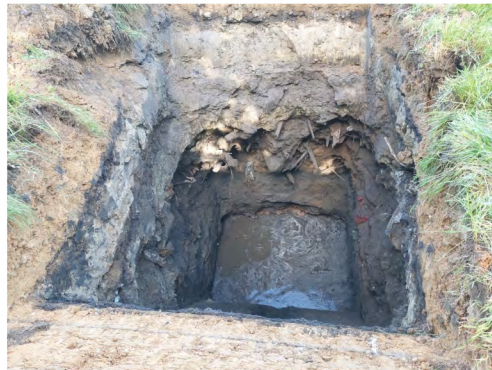
1.4	[LANDFILL] SILT, minor sand (fine to coarse), black/grey mottled orange, stiff, moist, slightly plastic, contains abundant (20%) construction debris including metal pipes, concrete, fabric, fence posts and wires

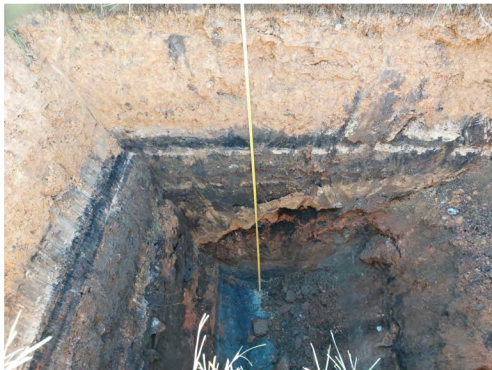
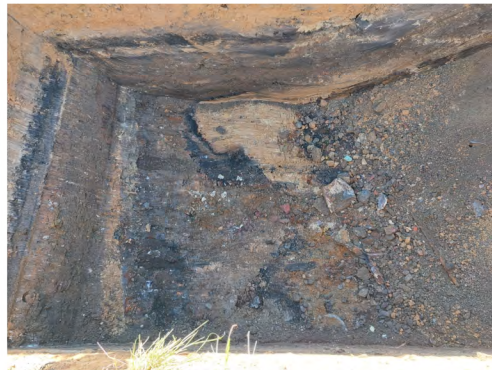
1.0 - 2.0	[LANDFILL] SILT, sandy (fine to coarse), black mottled grey/orange, hard, moist, slightly plastic, contains 20% burnt debris and inferred boiler ash 1.5 m: contains 20% construction debris including red brick and concrete 1.8 m - 2.0 m: CAPPING MATERIAL, very stiff 2.0 m: contains 40% general refuse including waste, fence post/wire, metal pipes and concrete	Fill	[Symbol]			>200

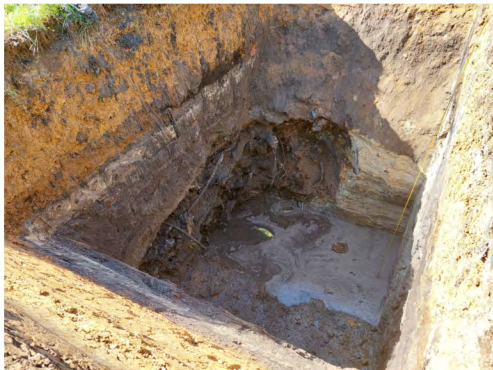
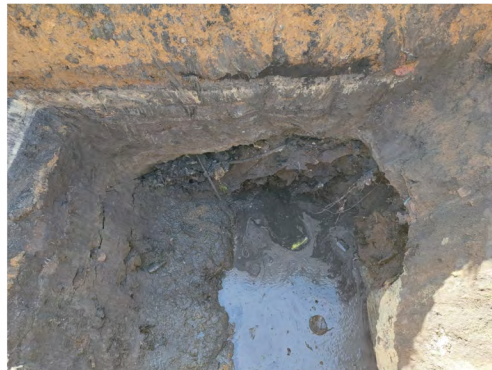
2.6	2.6 m: becomes larger debris (>1 m), car axle, 80% refuse													
2.8	2.8 m: becomes wet													
3.4	SILT, some sand (fine), minor clay, grey streaked orange, very stiff, moist, slightly plastic	Tauranga Group		○		110 (34)
