Kaikoura 2016 earthquake

Beneath the waves

Kaikoura–Cape Campbell

KAIKOURA

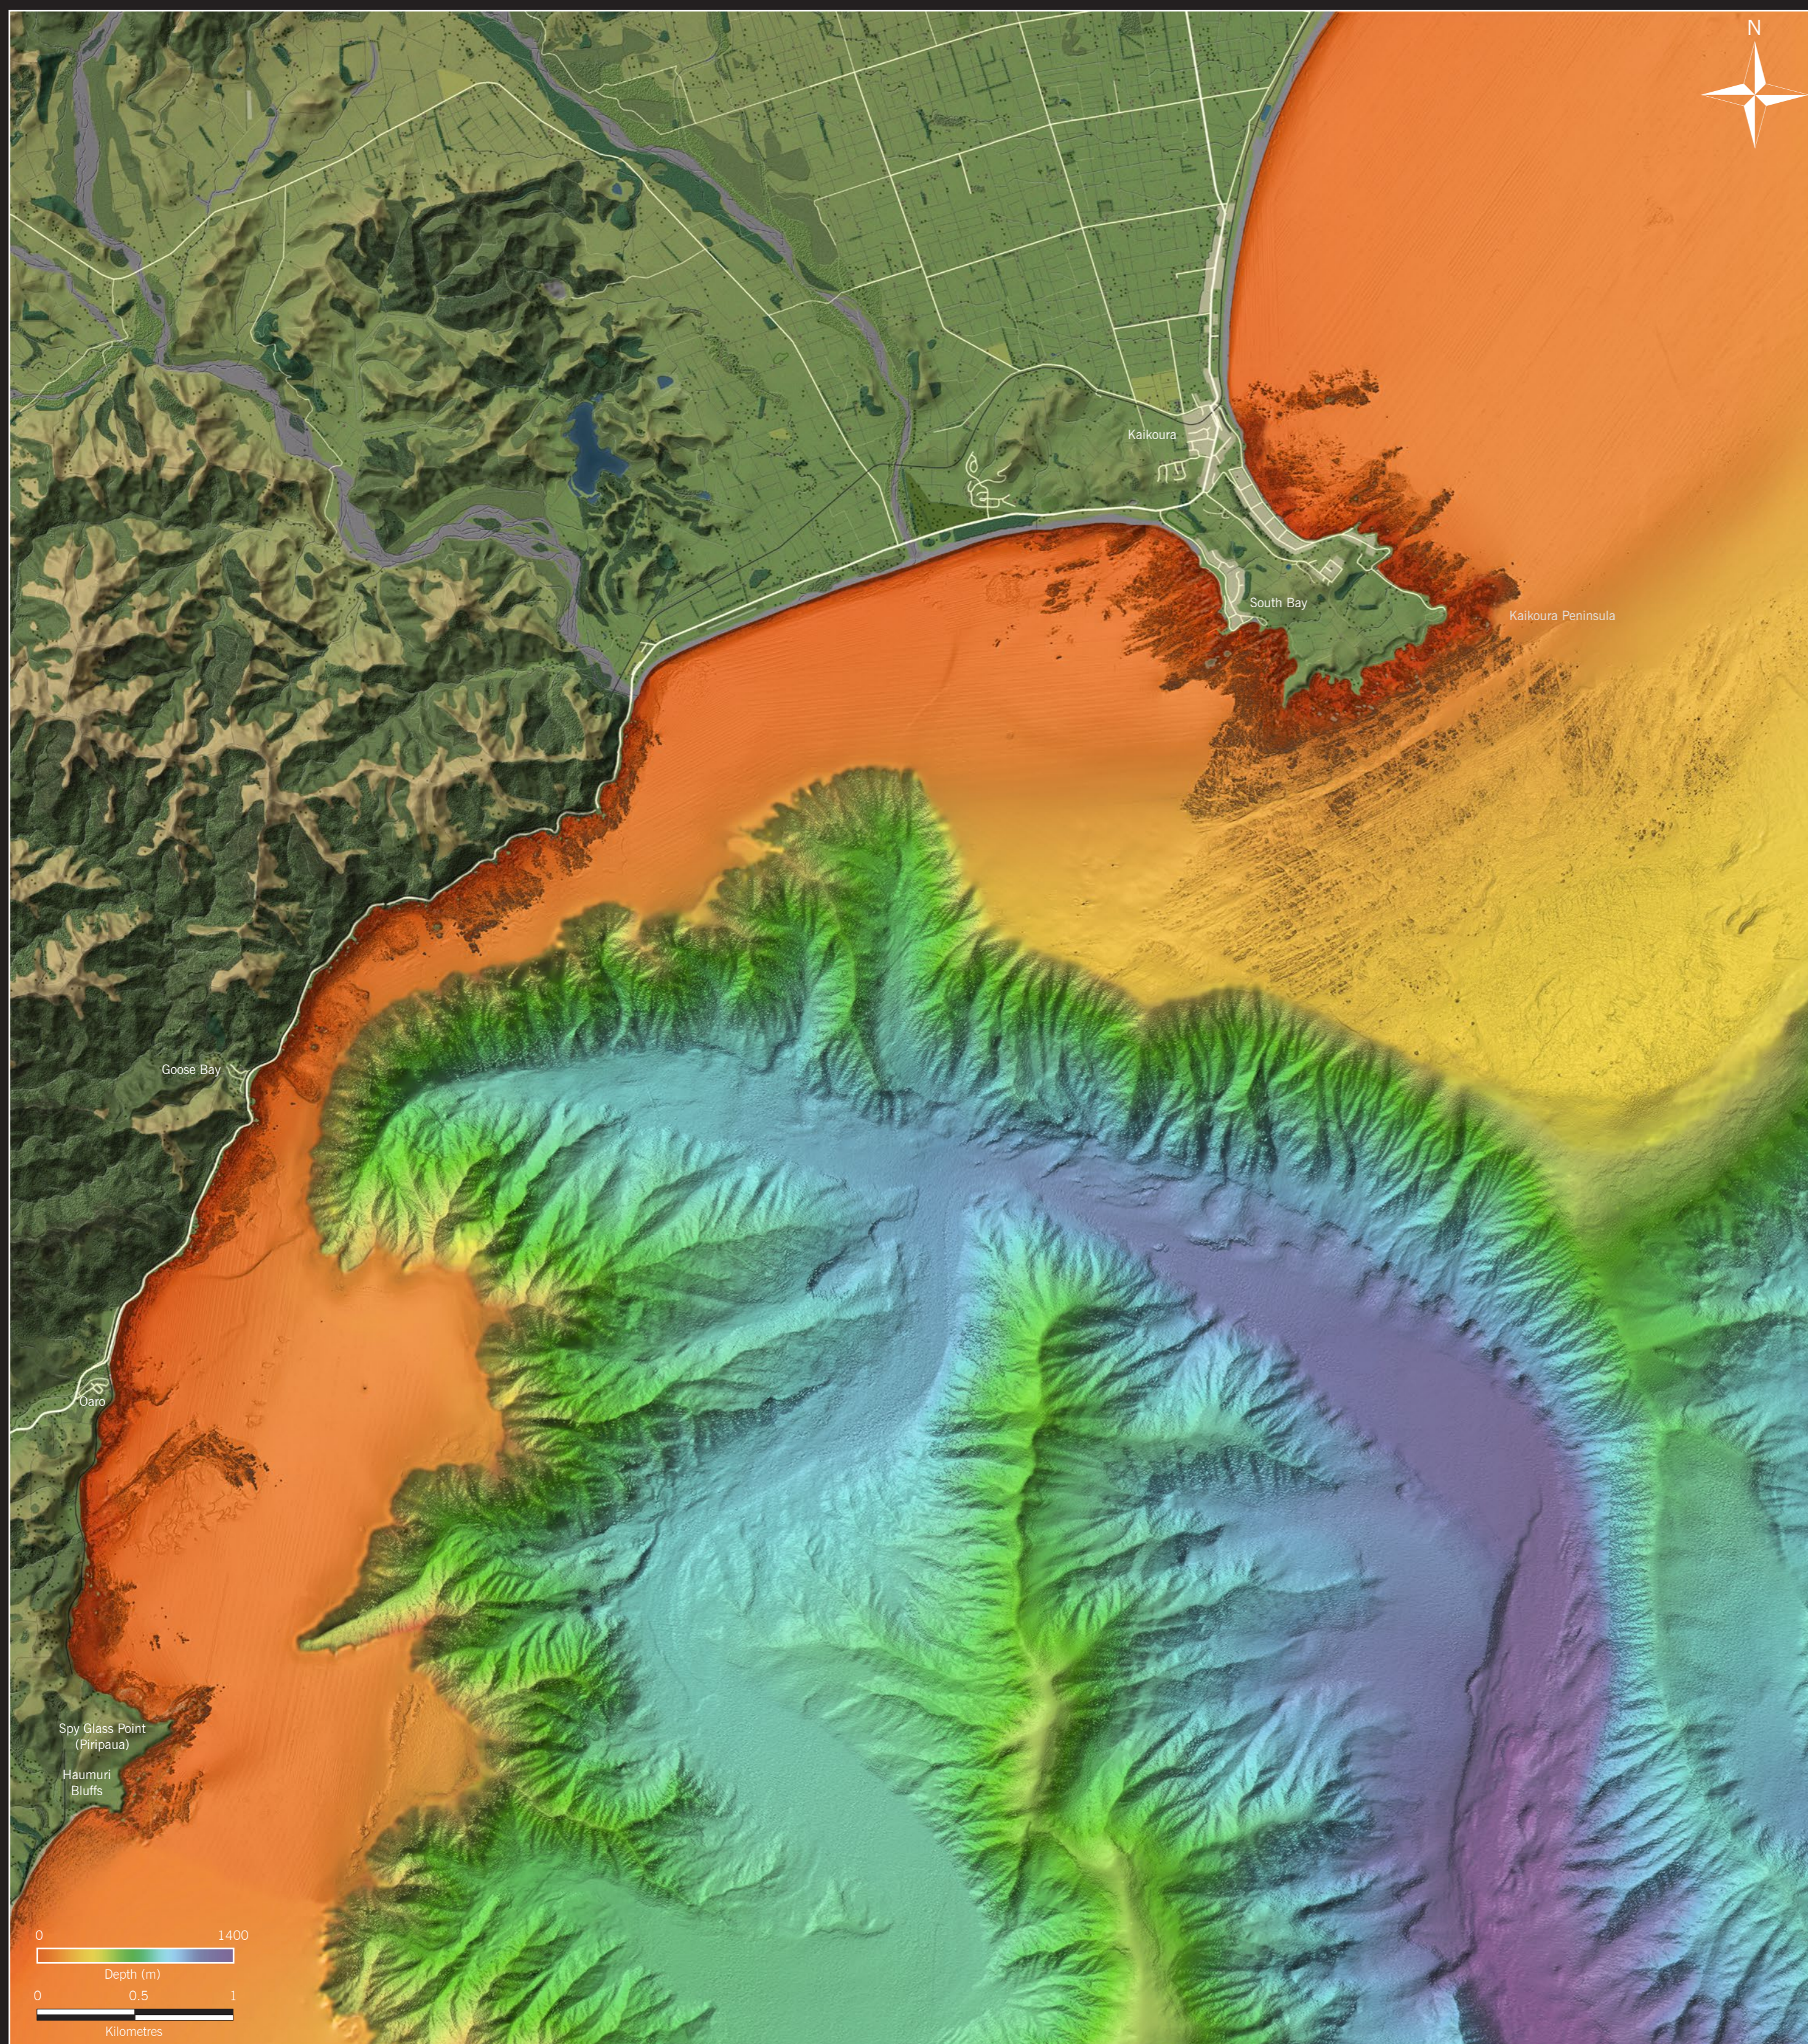
Here we see in unprecedented detail the nearshore rocky reefs and platforms rising above the flat seafloor around Cape Campbell, an area with high biodiversity and biological productivity. Many earthquakes over time have uplifted, faulted and folded the rocks resulting in the complex patterns we see today. The larger map to the left also shows rocky reefs around the Kaikoura coastline. As well, sediment erosion, transport and deposition within the offshore canyons is evident. Seven key areas were mapped specifically to identify the distribution and extent of rocky reefs. Shallow boulders and gravel, and undisturbed deeper, soft muddy substrates were also revealed.

Following the Kaikoura 2016 earthquake Land Information New Zealand (LINZ) commissioned a multi-beam hydrographic survey of the Cape Campbell to Kaikoura coastline, in partnership with Fisheries New Zealand. Mapping the seafloor from Kaikoura to Cape Campbell comprised over 140 days on the water. Multibeam echosounders were used to reveal the shape and depth of the seafloor. The echosounders produce a fan-shaped array of acoustic beams that reflect off the seafloor, enabling the surveyors to precisely map the seascape in detail. This survey has gathered more than 18 billion depth-data points over 400 km². Knowledge of the seafloor provides valuable information about the physical benthic habitats aiding evidence-based, sustainable management of this iconic seafloor.

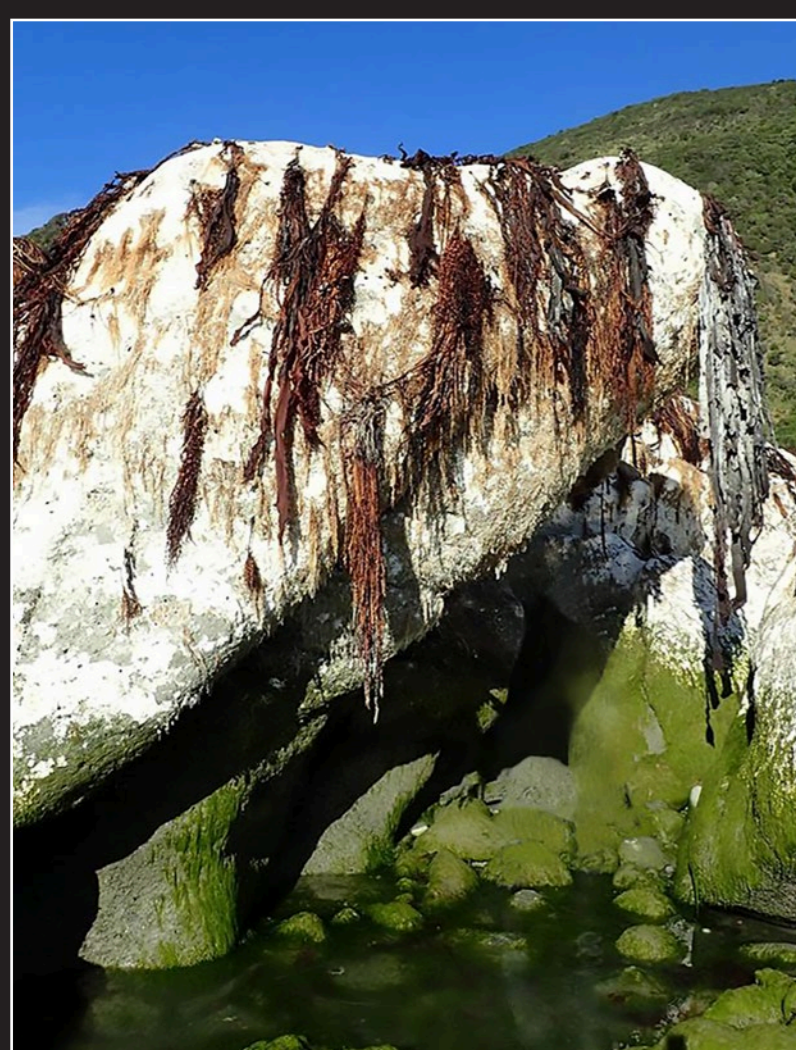
Variable Uplift

Some areas were largely unaffected by the earthquake whilst other areas were uplifted by up to 6m. Sometimes this variation occurred over short distances across a bay. Perhaps unsurprisingly, the shallowest areas were most affected by the death of intertidal organisms as a consequence of the elevation changes and recovery may take a long time.

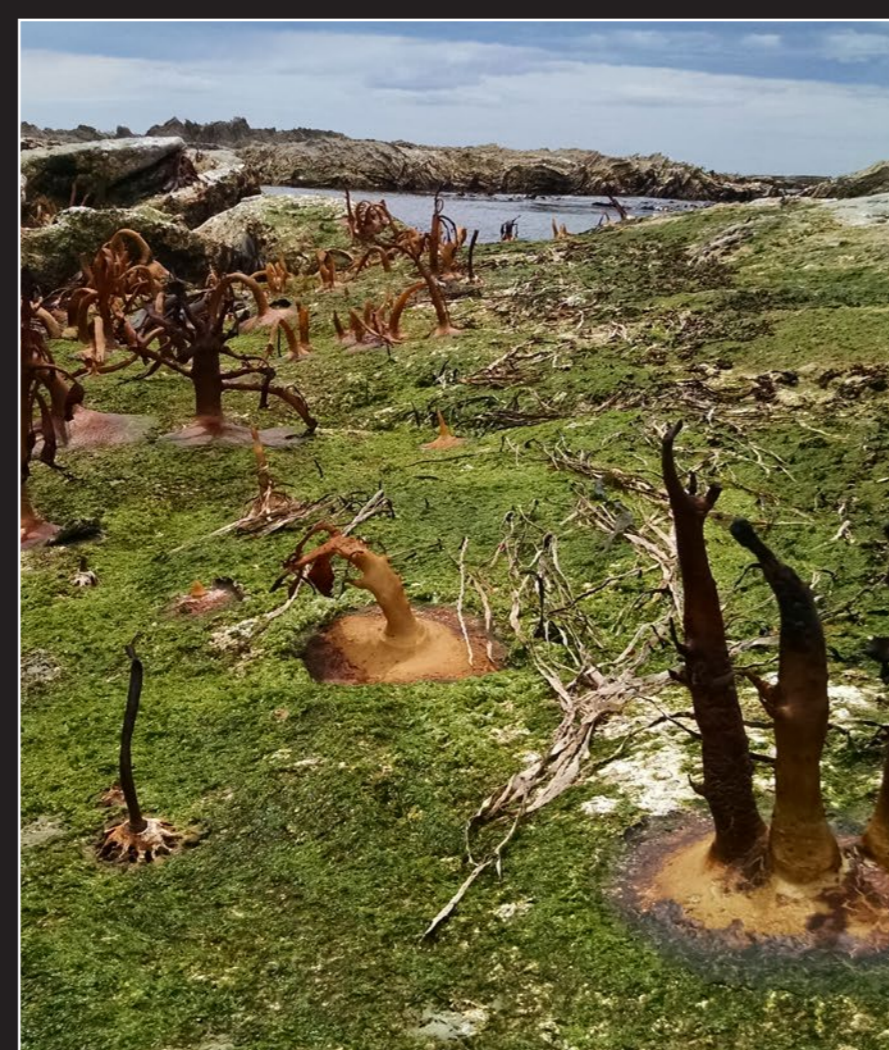
Biological Impact

Rocky reefs provide complex habitats that support dense macroalgal stands that are ideal habitats for paua, crayfish, butterflyfish and a diversity of sponges and other encrusting invertebrates. In the most affected areas there were large scale die-offs of a range of algae and invertebrates including bull kelp and paua, and subsequent blooms of green algae.

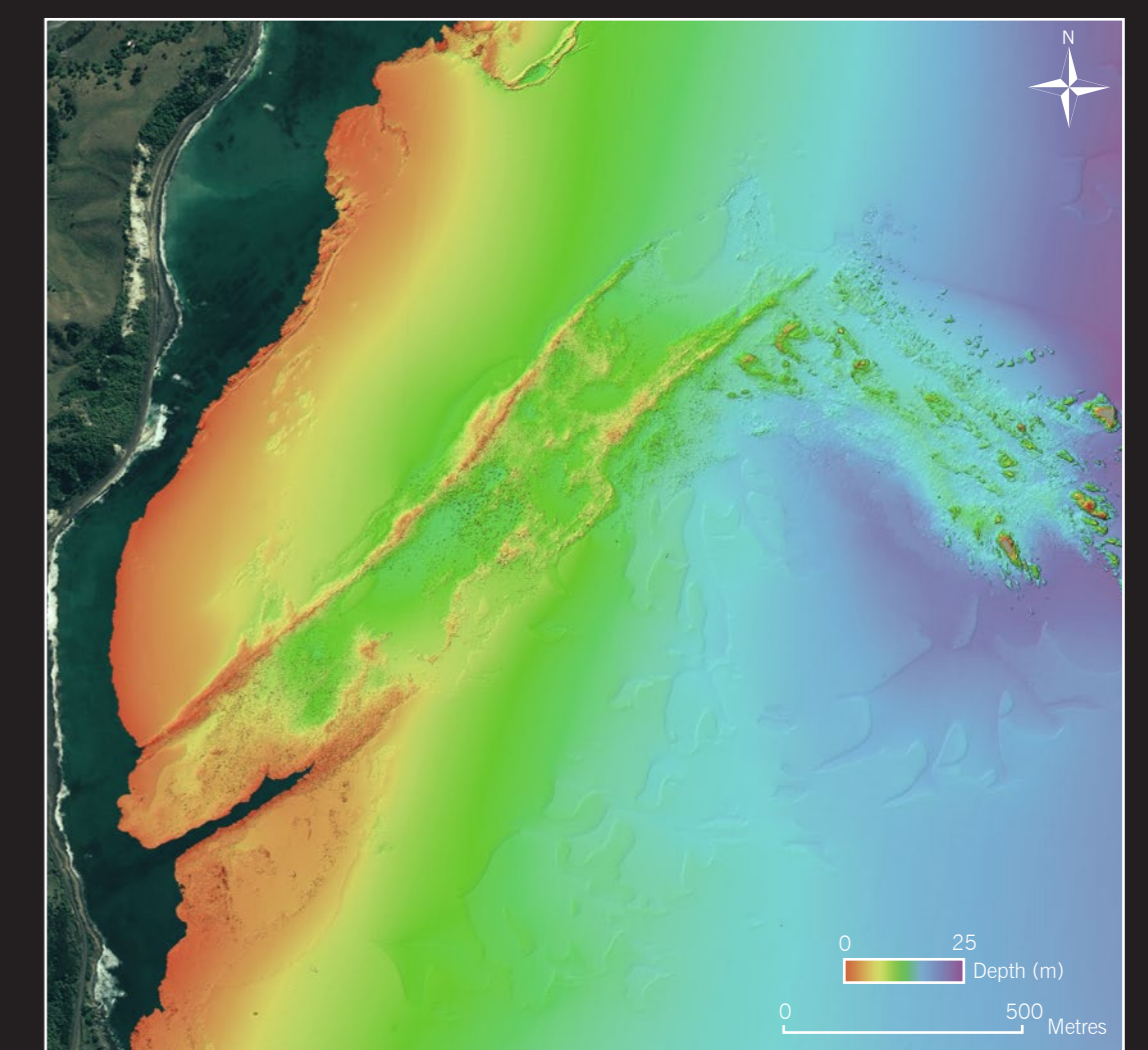
Rocky Reefs

The consequences of earthquakes on marine ecosystems are not well understood. This survey data will serve as a baseline to gauge impact and subsequent recovery from the 2016 earthquake, as well as underpin ongoing monitoring and management of marine resources. The newly acquired multibeam bathymetry maps allow for the identification and description of rocky reef habitats, areas essential for ecosystem recovery. These reefs extend out from the shoreline and are highly complex. Their rugged hard substrates are often surrounded by patchy boulder and gravel aprons, which are overlain by rippled sands or fine muddy sediments.

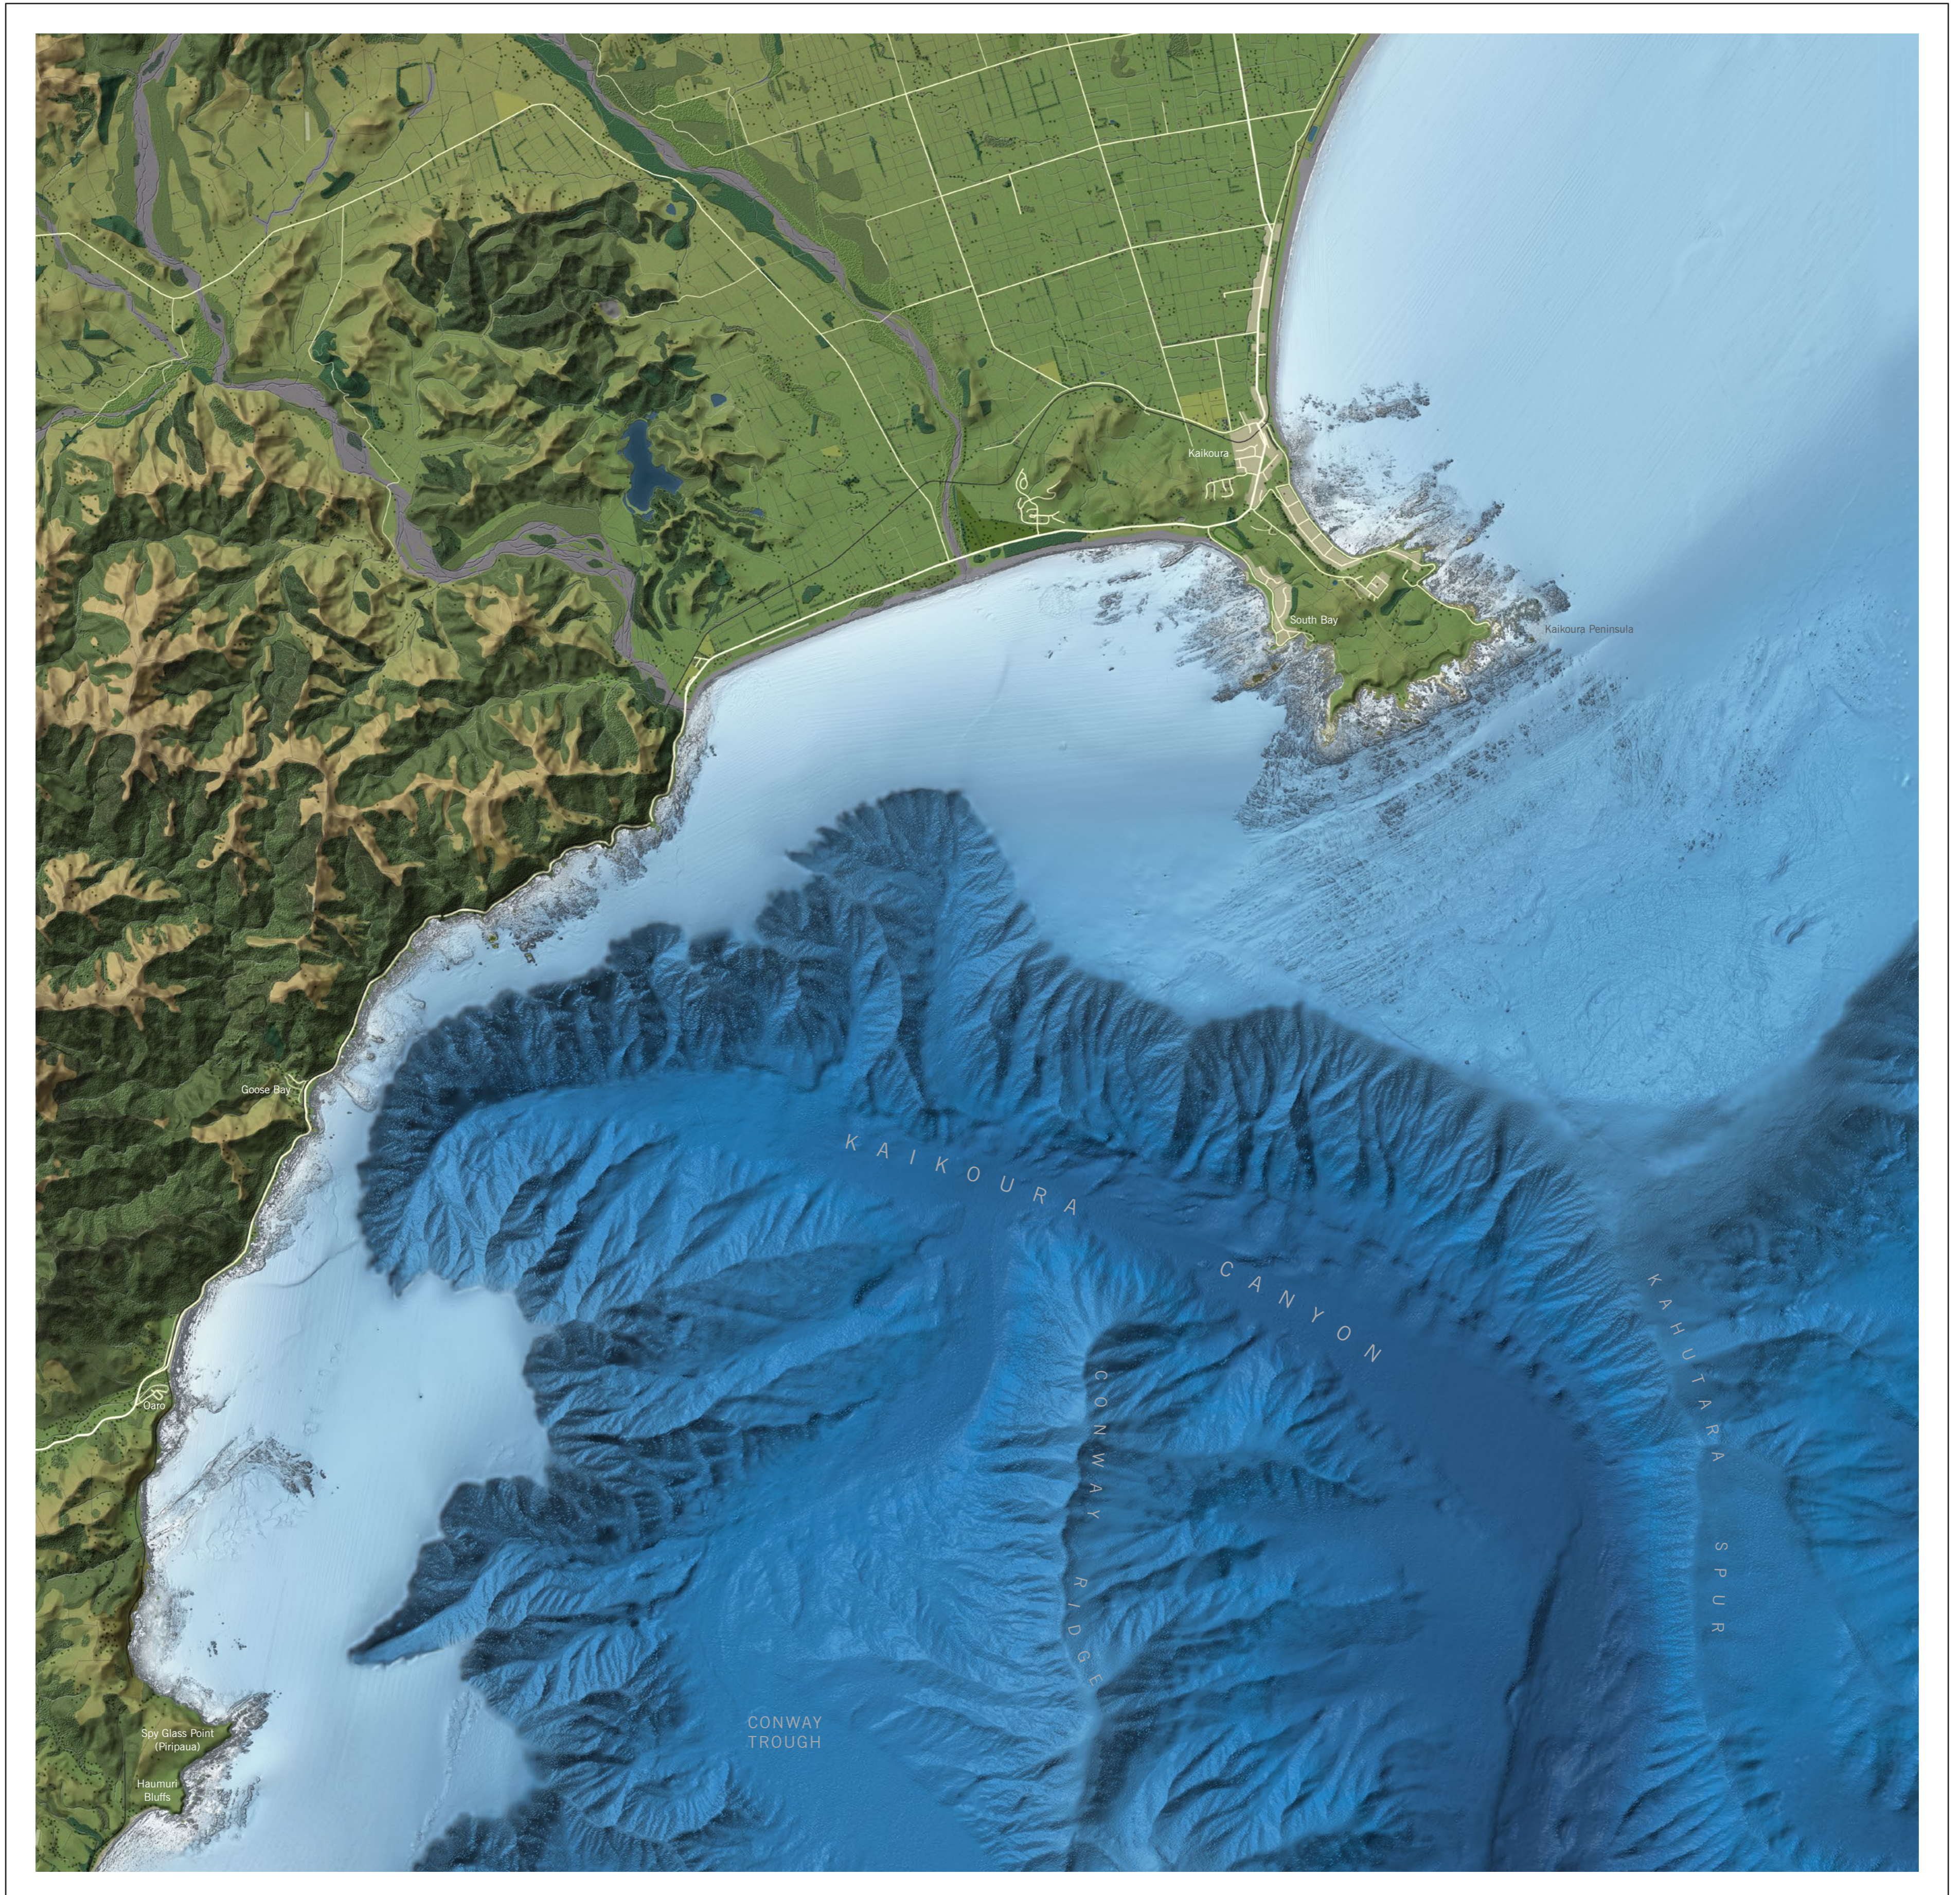
The variability and complexity of the Kaikoura seafloor is revealed in this map. Sediment erosion, transport and deposition within the offshore canyons is evident. However, here we also see in unprecedented detail the nearshore rocky reefs and platforms. Seven key areas were mapped specifically to identify the distribution and extent of rocky reef habitats. As a result of the Kaikoura 2016 earthquake the seabed rose up to 6 metres along the Kaikoura and Marlborough coasts, posing a hazard to safe navigation and impacting the marine environment. Mapping the seafloor from Kaikoura to Cape Campbell comprised over 140 days on the water. Multibeam echosounders were used to produce a fan-shaped array of acoustic beams

that reflect off the seafloor, enabling the surveyors to precisely calculate the depth of the seafloor, and map the seascape in detail. This survey has gathered more than 18 billion depth-data points over 400 km². LINZ will use the information to produce world-class nautical charts, making it safer for the vessels that use these waterways. The survey also provides Fisheries New Zealand, the Department of Conservation and Regional Councils with a data-rich appraisal of the coastal marine area to assist decision makers and the community to better understand, sustainably manage and protect the important coastal ecosystems.
