FORMER TOKANUI PSYCHIATRIC HOSPITAL  
DEMOLITION AND REMEDIATION  
EXISTING DISPOSAL SITES – INTRUSIVE INVESTIGATION REPORT

146 TE MAWHAI ROAD  
FORMER TOKANUI PSYCHIATRIC  
HOSPITAL, TE AWAMUTU

Project No.	33097	Approved for Issue	
Version No.	3	Name	Sean Finnigan
Status	Final	Signature	 
Authors	E Bish, T Bohles, S Finnigan		
Reviewer	S Finnigan	Date	26/06/2024

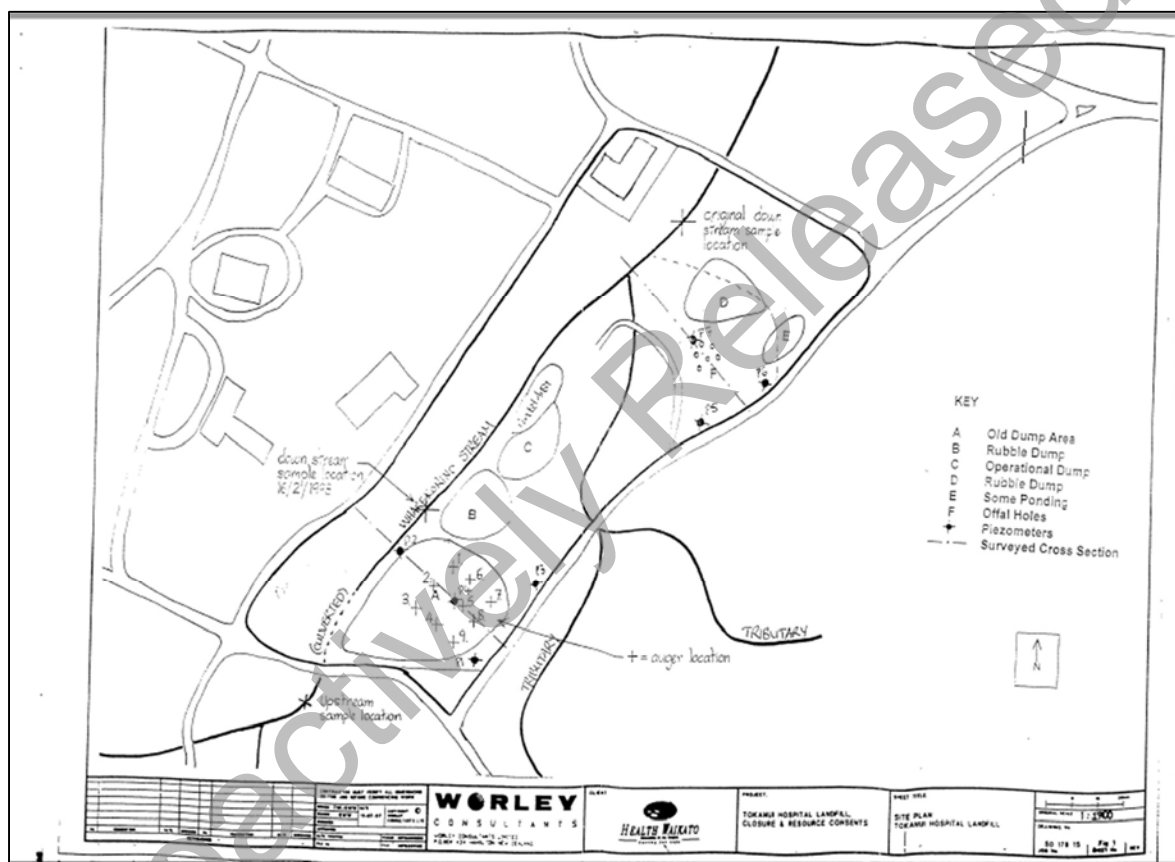
Figure 2: Closed Landfill Site Plan ex Worley

C	Was used until late 1997 for dumping of refuse, comprising coal ash, wastewater sludge, garden waste and general refuse. Stream ponds in swampy area at base of this area. Appendix E of the AEE shows a closure plan for Area C and how it was to be pulled back from the stream edge, placed behind a confined bund, capped with 600mm low permeability clay and 150mm topsoil, with the swampy area backfilled with clean material, (refer Figure 3).
D	Mainly building materials/concrete from demolished site buildings (referred to as cleanfill materials in AEE); fill extends partially into gully area, obstructing stormwater flow path from road, causing some ponding.

E	Site where runoff from road ponds as Area D blocks natural flow path. Remains of old concrete and asphalt also seen scattered around this general area.
F	6 x offal pits; thought to be 4-6m deep. Used to dispose of drugs, needles, etc.
Other (Areas H& I)	Discussions with others indicated that the area directly opposite Wharekōrino Stream from Area A may have been filled at some time earlier than construction of the cells in Area A, with the stream being culverted through this area at the same time. In addition, an area directly south of FTPH buildings 30 & 31 appears to have likely been filled during construction of the southern area of FTPH.

The area of filling shifts east and north east from as early as 1957, filling the area, marked as Area A in the 1998 AEE (Figure 2). Early aerials show some buildings/dwellings in this area, but the majority of these were removed between 1966-1974. It was not possible to verify the closing year of the landfill (1988 from Table 2) due to the lack of any historical aerials covering the 1980s.

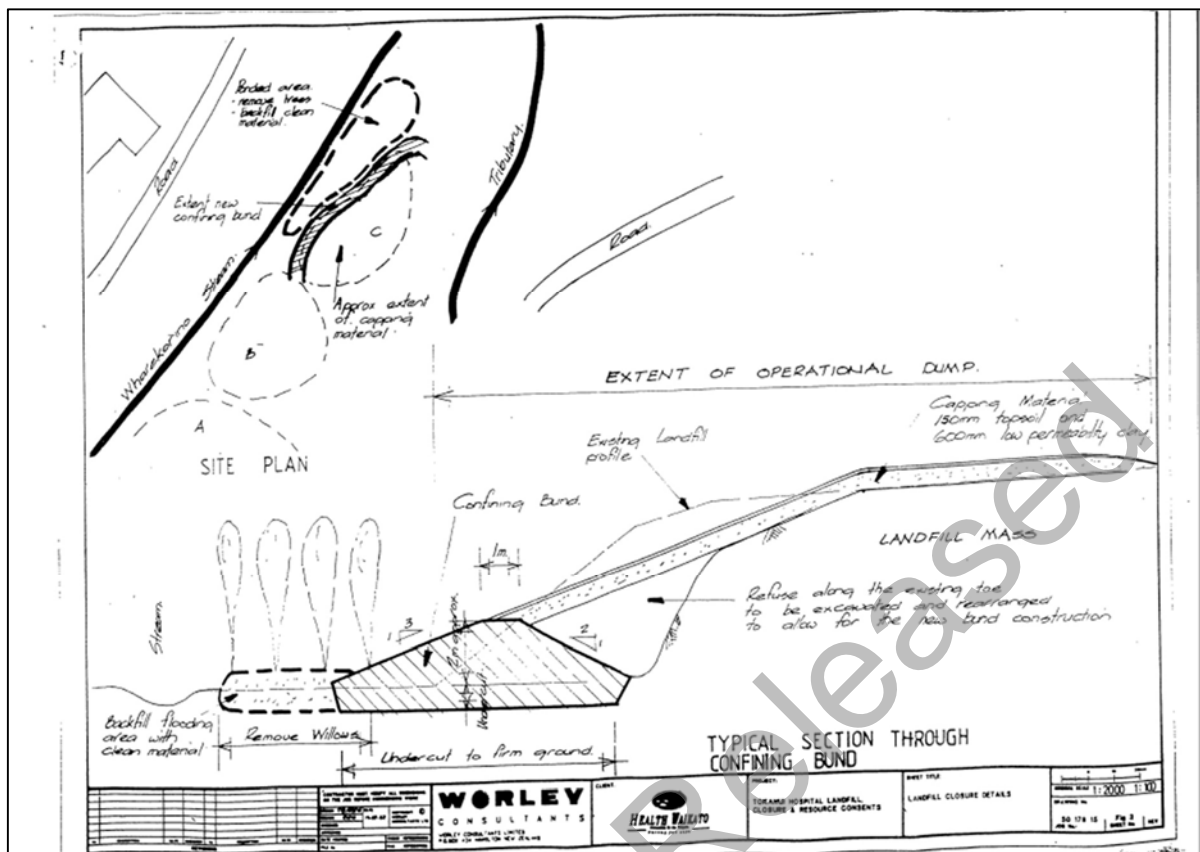
Figure 3: Closed Landfill – Closure Details for Area C (ex Worley)

- Area C is shown as having an existing bund between it and the stream, and there is reference to a new imported clay bund, indicating that at least some of the closure works referred to in Figure 3 were completed for this area.

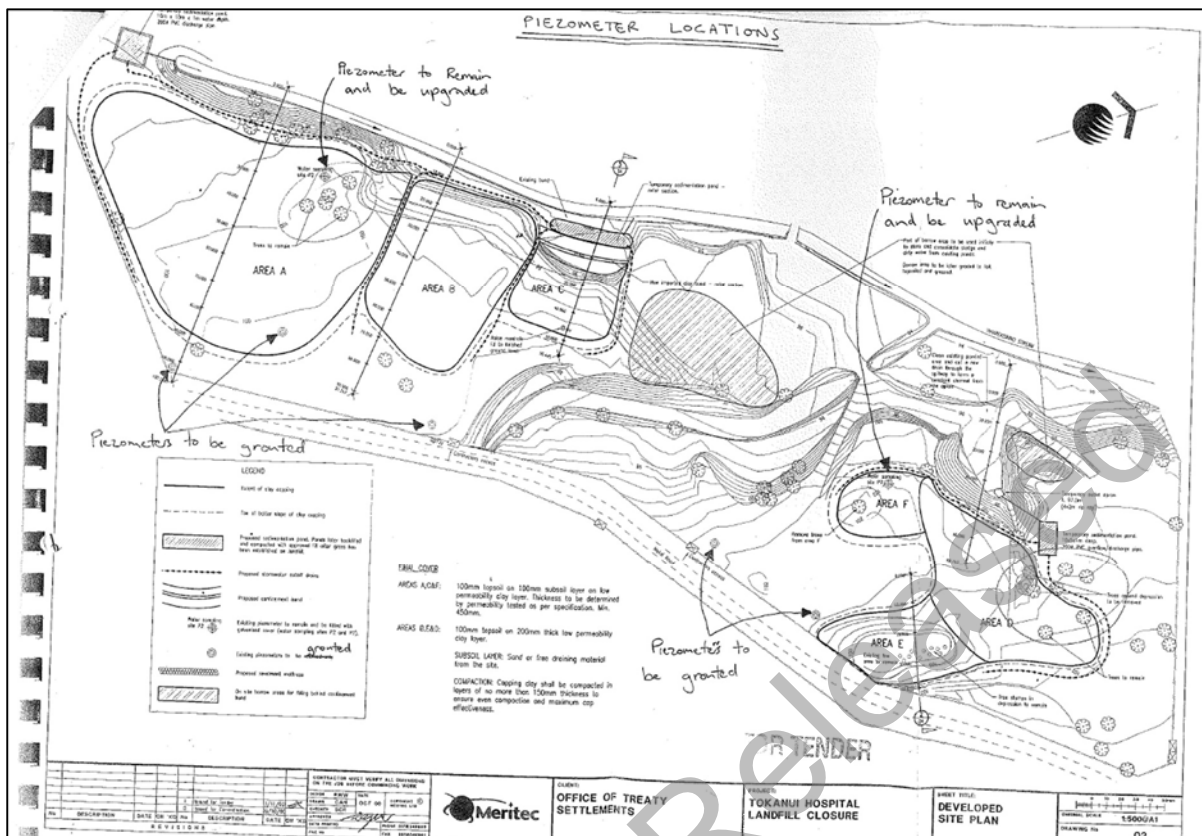
Figure 4: Meritec Developed Site Plan (October 2000)

The Meritec “Developed Site Plan” (Oct 00) (Figure 4) has modified the area and extent of some of the landfill areas A-F from the Worley AEE (Figure 2) and shows five cross-sections through Areas A, B, C, D (part) and E, none of which were included in the CWR documentation. This plan also shows:

- It also refers to the final cover comprising:
  - Areas A, C and F: 100mm topsoil on 100mm subsoil layer on low permeability clay layer. Thickness to be determined by permeability testing as per specification; minimum 450mm.

- Areas B, D and E: 100mm topsoil on 200mm thick low permeability clay layer.
  - Subsoil layer: sand or free draining material from the site.
  - Compaction: compacted clay shall be compacted in layers or no more than 150mm thickness to ensure even compaction and maximum cap effectiveness.

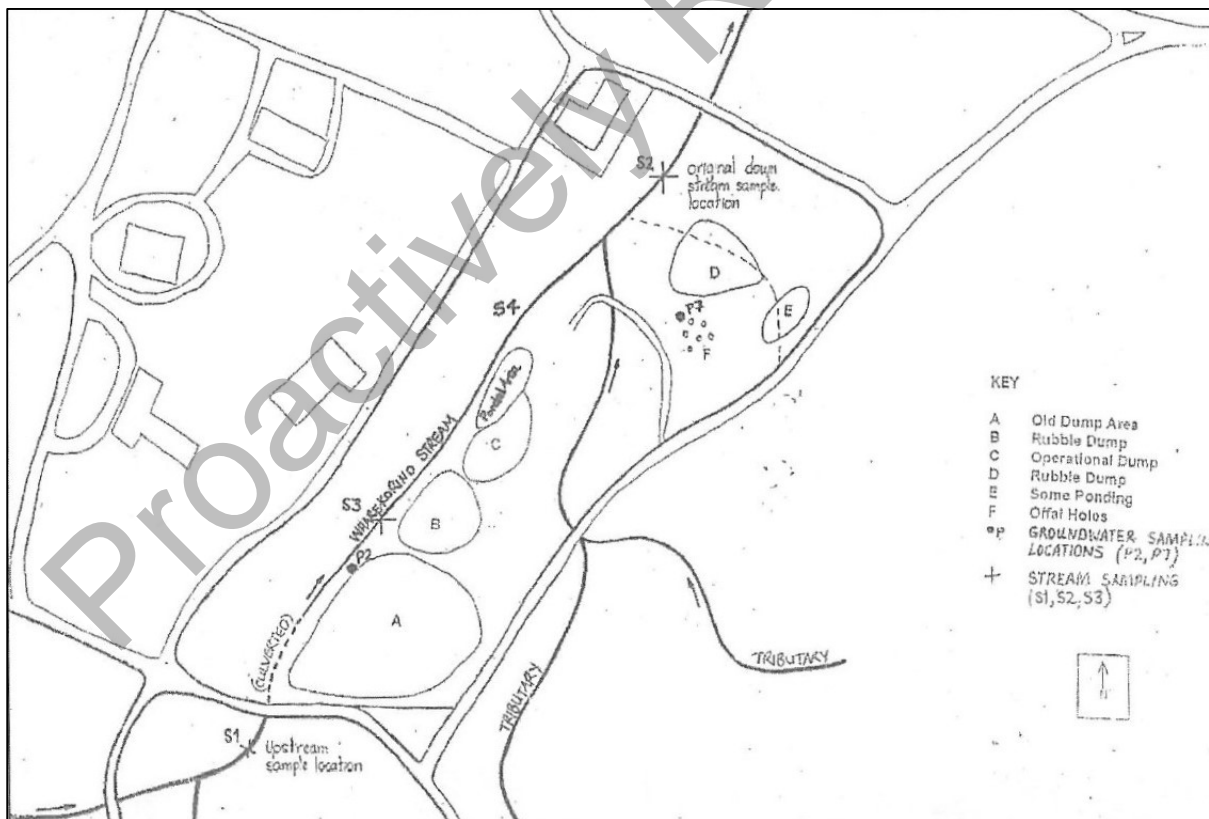
Figure 7: Location of stream and bore (groundwater) sampling sites relative to landfill areas

Long term monitoring data appears to show that boron is leaching from the landfill into the stream, being consistently present at elevated levels in the groundwater in one monitoring bore (refer Figure 5). All stream samples have recorded boron levels below the ANZECC freshwater guidelines for protection of 95% aquatic species, but the monitoring data shows that boron levels are consistently higher downstream of the landfill, with some data indicating boron leaching may primarily be coming from landfill areas A, B or C (refer Figure 6).

The likely source is coal ash, which is understood to have been used as a cover material in some landfilling areas.

A single round of sediment sampling was undertaken by FTL in April 2023 from the four sampling locations S1-S4 shown in Figure 7. Cadmium and zinc were higher than the upstream sample (S1) in the downstream samples (S3, S4 and S2), while boron was only detected in one sample (S3) closed to landfill area A. The elevated concentrations were well within the ISQG-Low trigger values with three times dilution (and even without allowing for any dilution). GHD also did some stream sediment sampling but further downstream by the Wastewater Treatment Plant and found slightly elevated cadmium and zinc levels (relative to background) in some samples but did not detect any boron. As boron is relatively soluble, this is not unexpected.

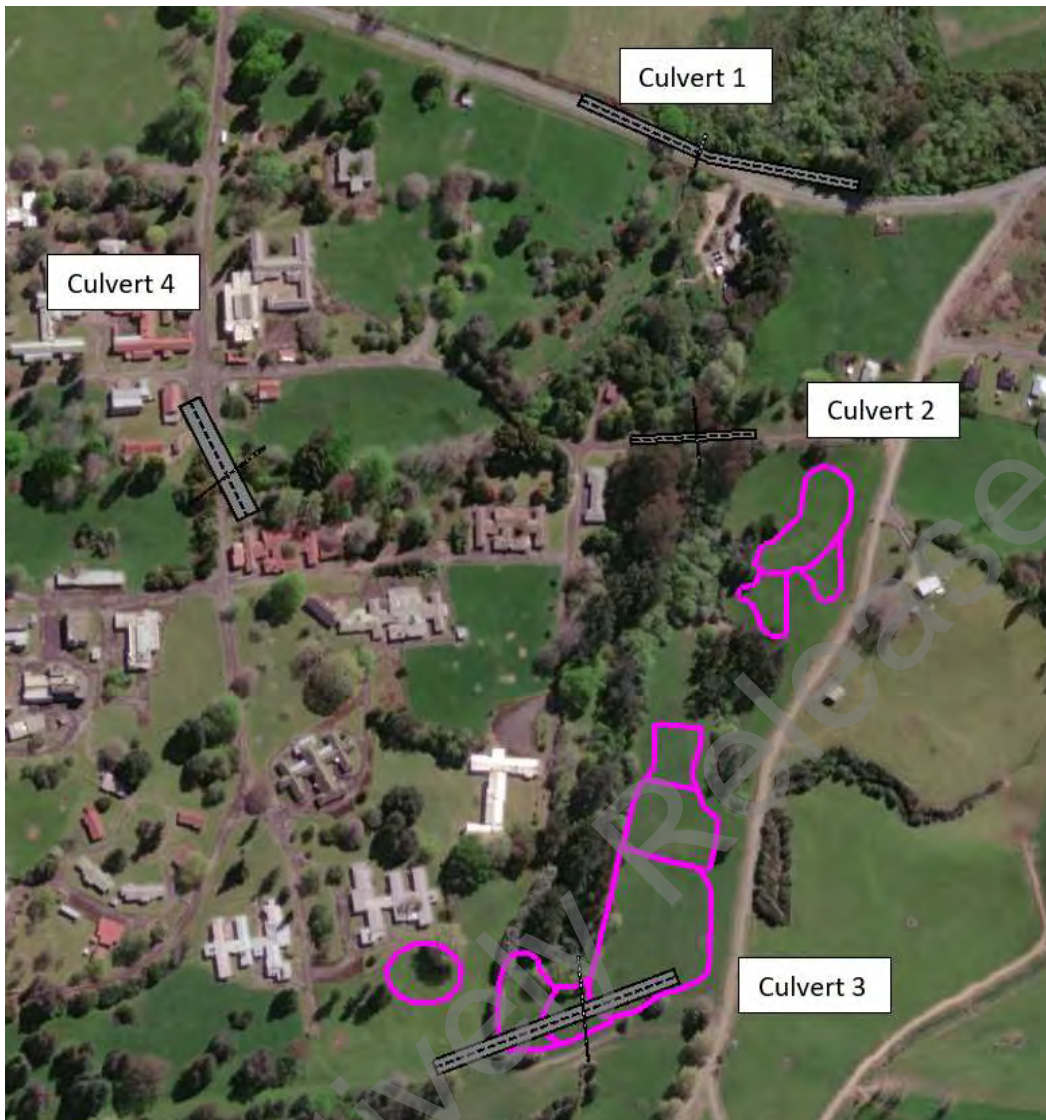
**Figure 14: Culvert locations relative to the landfill areas**

Culvert 3 comprises a 1350mm diameter pipe that pipes the Wharekōrino Stream through Area H of the landfill (refer Figure 14 for its location). Its condition is unknown, although it appears to not be subject to any significant blockage. Aerial photographs indicate this area was infilled over the period from at least 1957 to 1979, meaning that Culvert 3 is likely to be somewhere in the range of 44-65 years old, compared with a typical design life in the range of 50-100 years, depending on

Landfill area A effectively dams the stream, with culvert 1 passing under it. Modelling has shown this area to be inundated during a 1% AEP event, with the culvert being overtopped and flood waters flowing overland through Areas A & H. Velocities over the bunded area where the culvert passes may be quite high. This could result in localised scour/erosion along the overland flow path, potentially exposing the underlying landfill materials, and in the worst case, uplifting some of these materials and carrying them into the stream. This effect has not been quantified as part of the modelling done to date.

- Repair (e.g. lining), replacement or removal of Culvert 3. With culvert removal, this would involve transferring buried refuse in this area to another portion of the landfill, outside the floodplain.
- Removal of culvert 2, which will significantly lower flood levels adjacent to the landfill, subject to further investigation, design and an assessment of potential effects on upstream and downstream neighbours.
- Replacement of the landfill cap with a low permeability cap, complying with the consent conditions and/or current best practice. Associated ponding, settlement/subsidence areas would be repaired at the same time.
- Possible installation of a groundwater cut-off trench or similar to divert upgradient groundwater from passing through the landfill, so that it is no longer in contact with buried refuse.

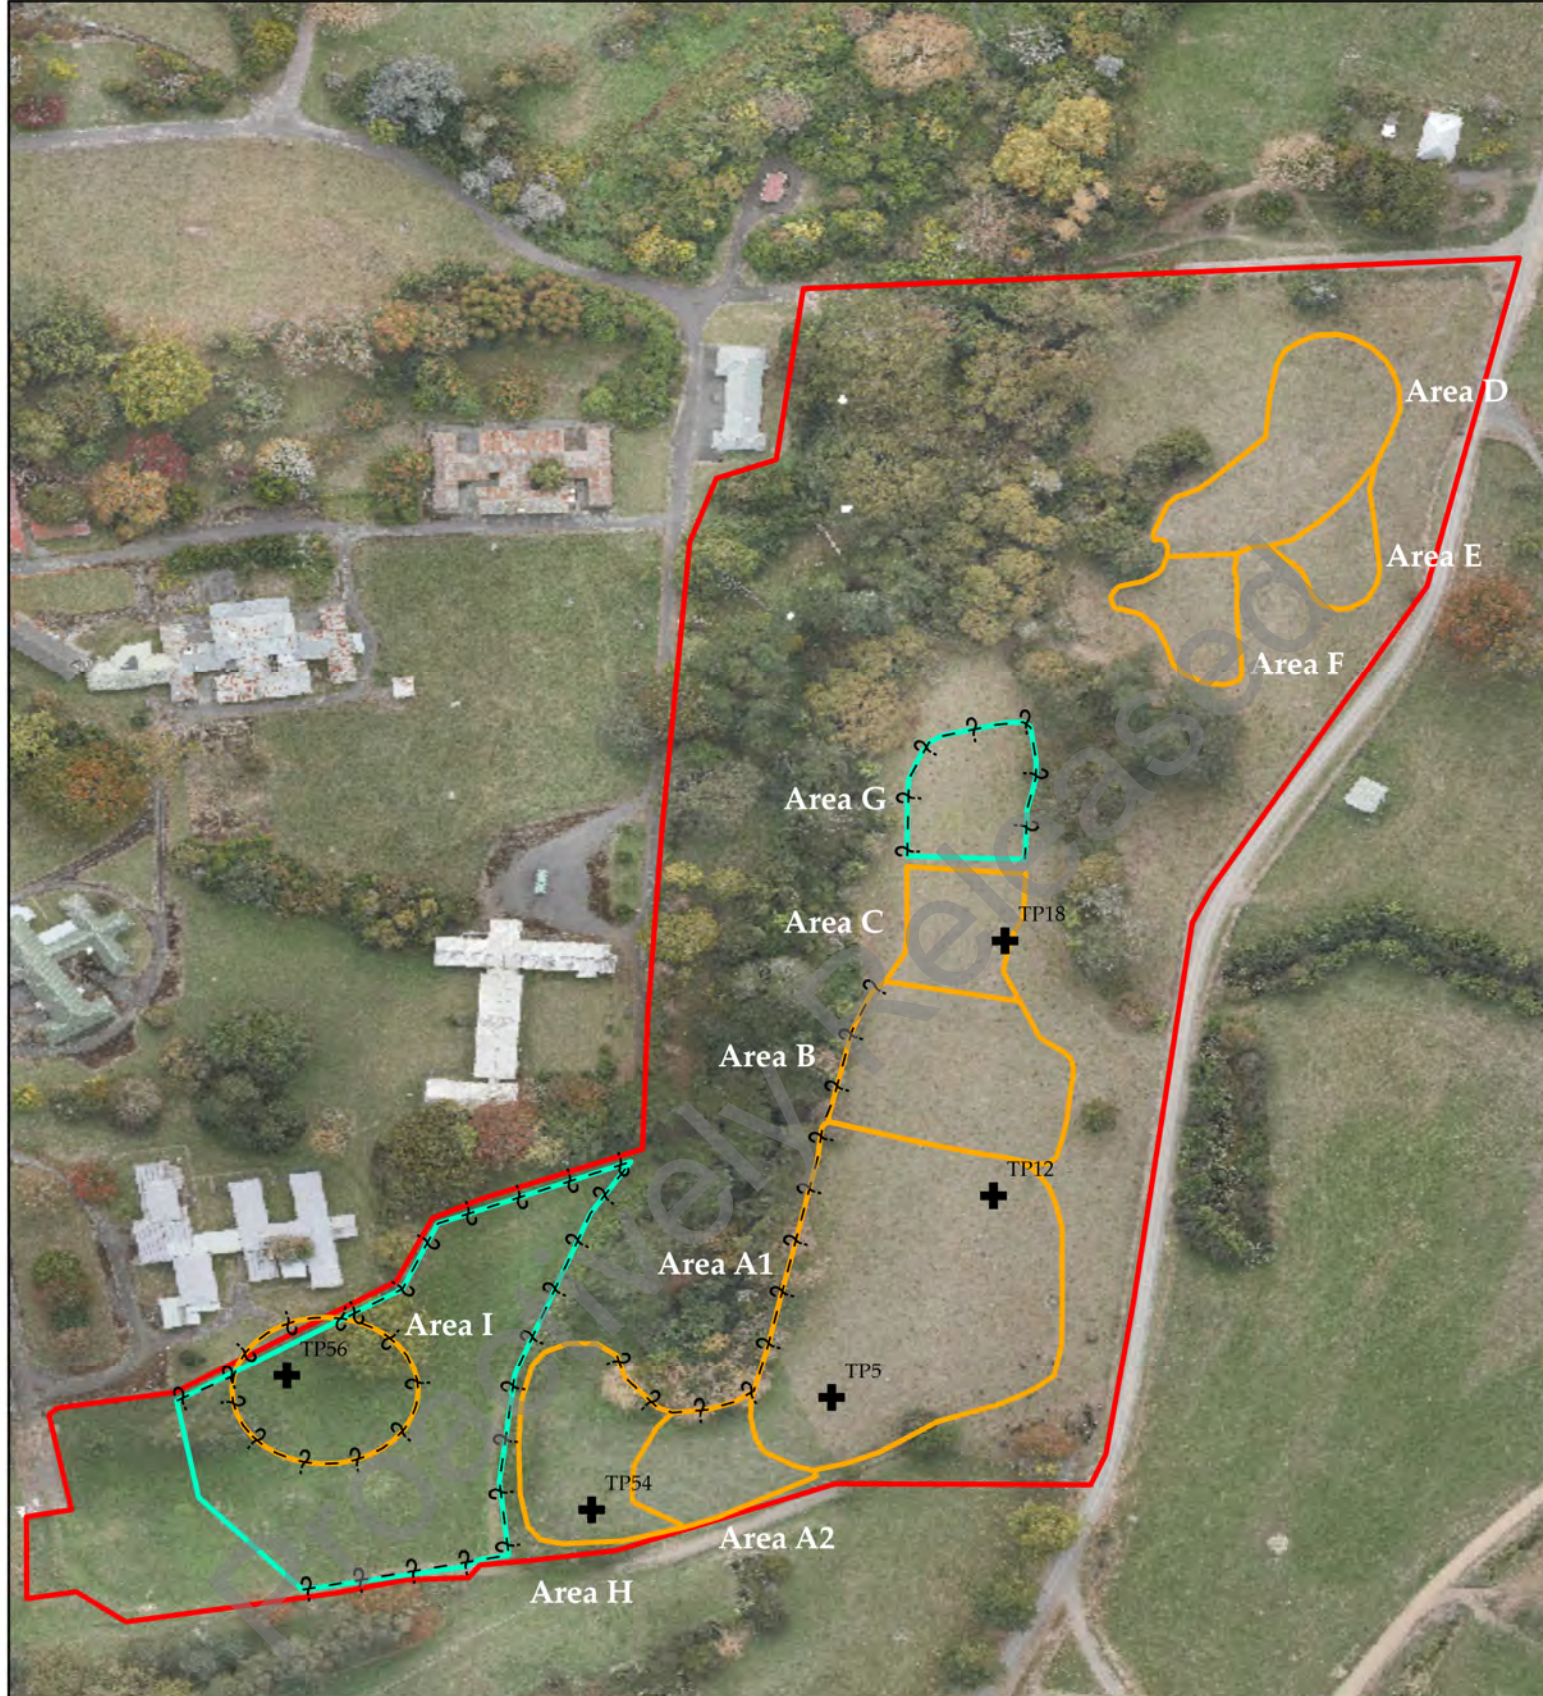
**Figure 10: Human Health Exceedance Plan - Surface**

Note: Majority of fill materials generally considered to be a risk to human physical health based on nature of fill.
