***Appendix B***

***Landfill Annual (2022) Walkover Survey Findings***

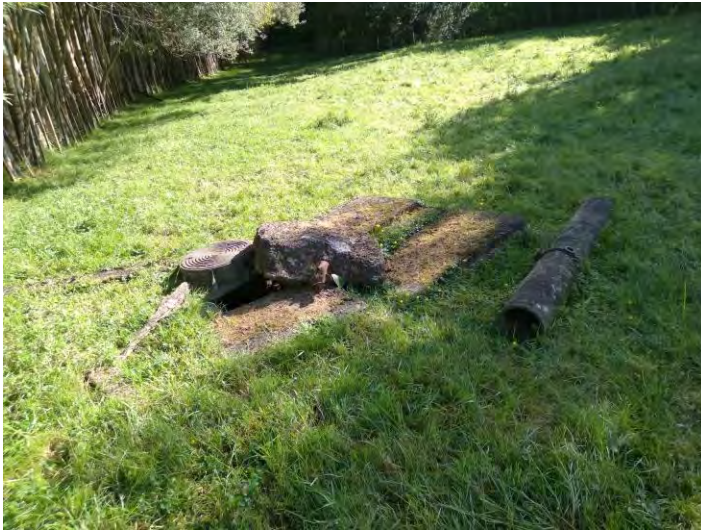
B1 – cement block/piping debris

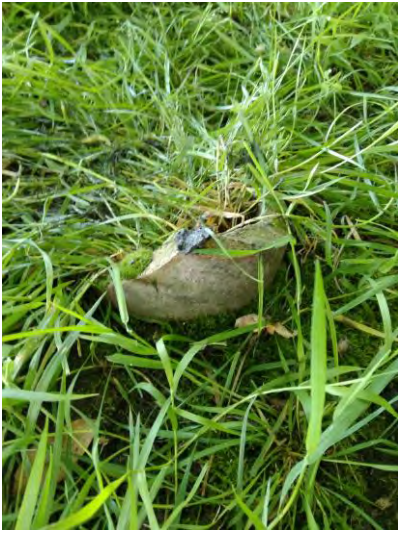
Protrusion of wooden posts and planks were visible at A1 and B1, which is reasonably far from the extent of the landfill in 1979, and at E4 at the edge of area A, which is more likely associated with filling activities. Cement blocks protrude at A1 and B1 which is reasonably far from the extent of Area A1 and likely dumped. They were also found protruding at A3, B4, D4, and E4 along the boundary fence line and western extent of Area A. 2 Ceramic posts were also noted to protrude at grid B3, at the extent of Area A.

B3 – Ceramic pipe protrusion

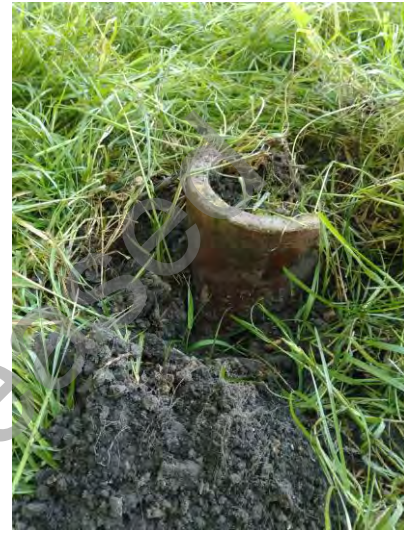
B3 – Ceramic pipe protrusion

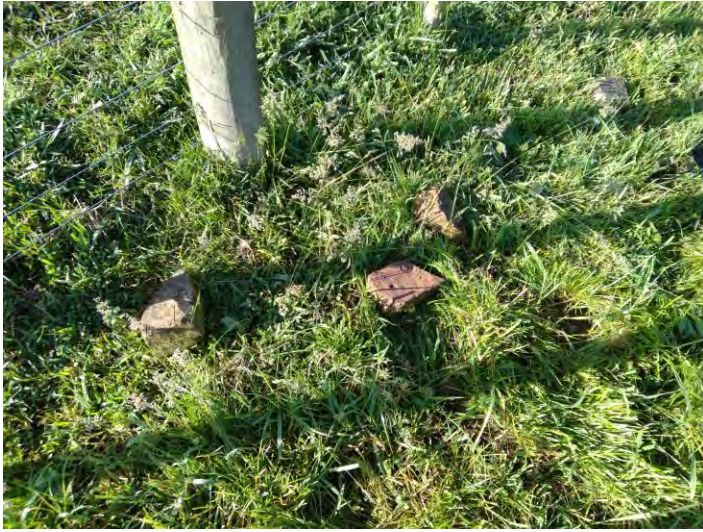
B4 – loose brick debris

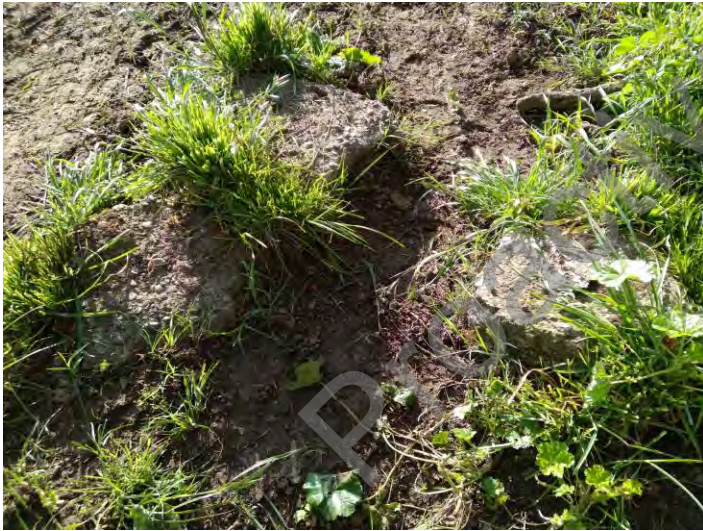
C7 – mixed cement blocks

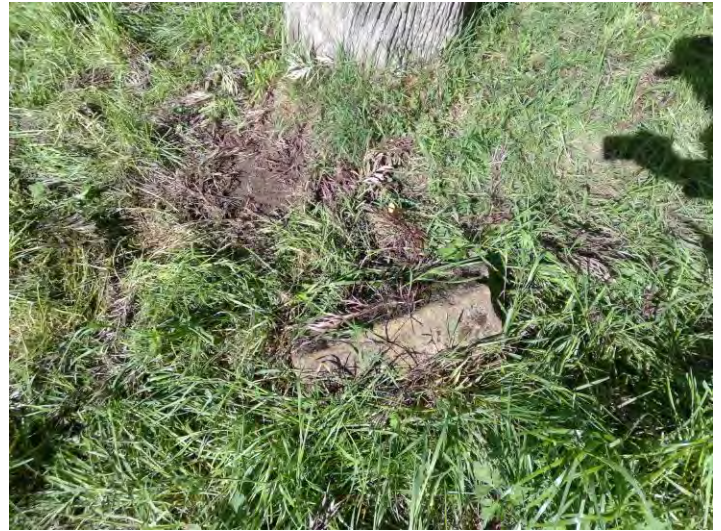
D4 – concrete block protruding

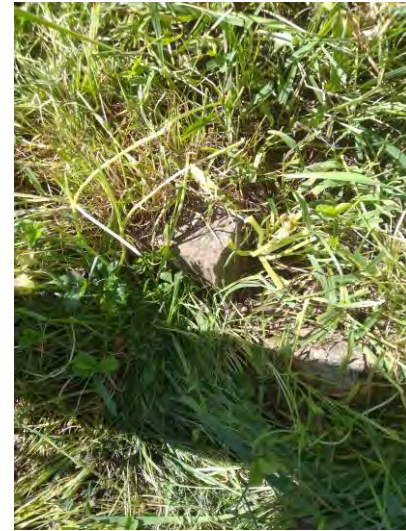
E4 – wooden post protruding

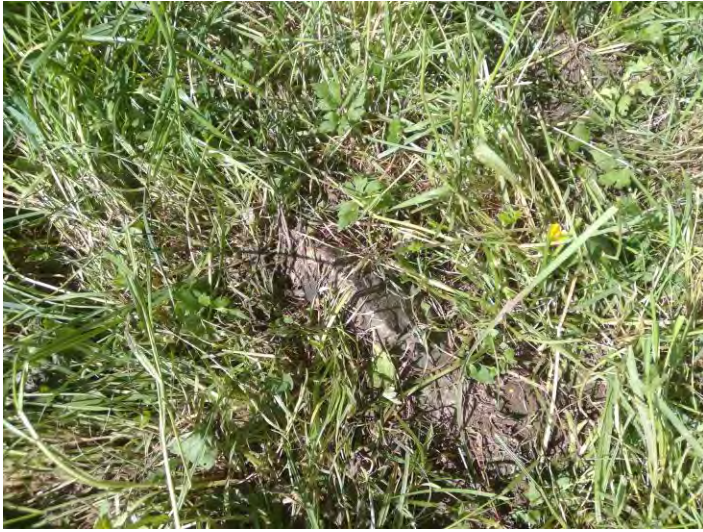
E4 – concrete protrusion

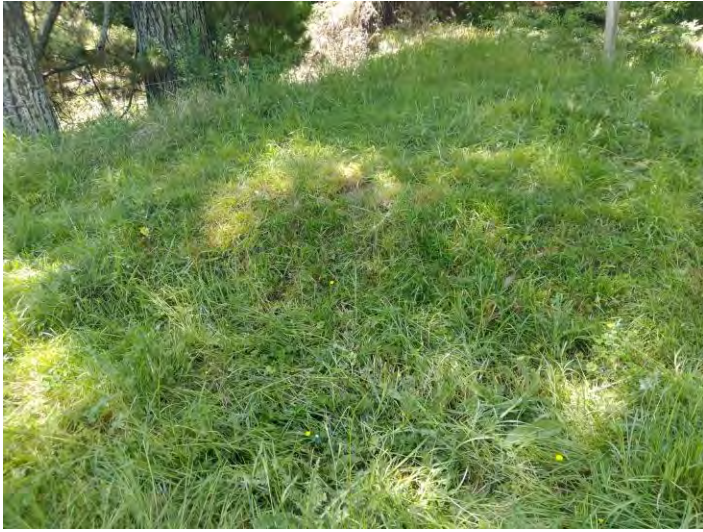
Area C: Area C was observed as mostly lush pasture, with large portions of ponding some visible subduction and subsidence. Grid J5 was the only portion of Area C where patchy pasture was observed, at the extent. Significant ponding was observed at H4 and minor ponding at K5, both located between the extent of area C and the Wharekorino stream. Ponding at both locations has been noted in previous years, and high stream flow is likely a large contributor. Localized subduction is observable at I5 at the extent of area near the fence line. Subsidence was noted at K6 at the north-eastern extent of area C.

K6 – minor subsidence

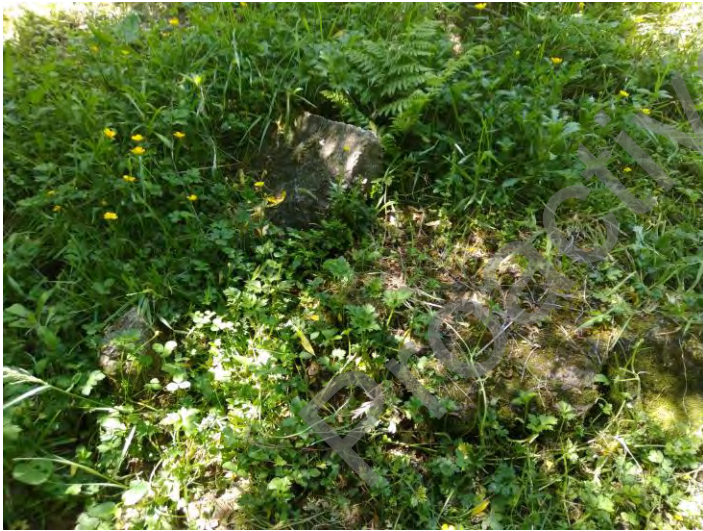
L5 – concrete/ceramic protrusion

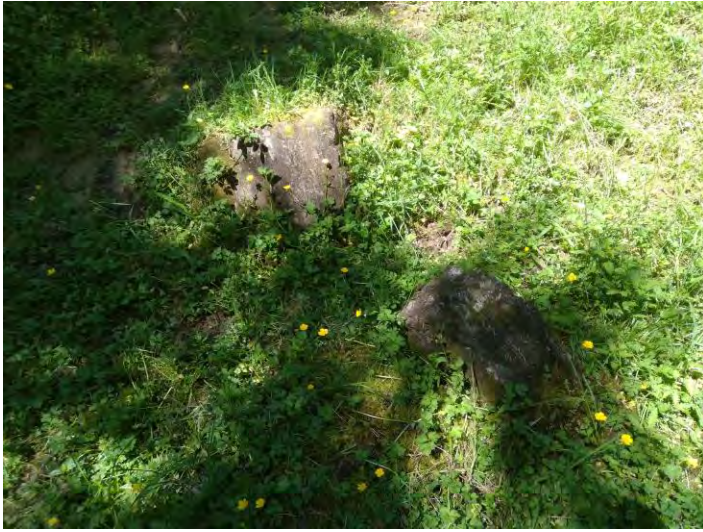
L5 – concrete protrusion

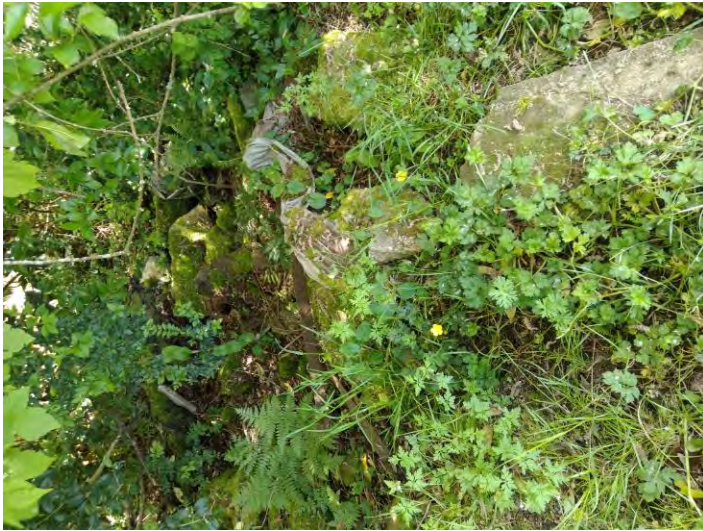
Area D: Area D was mostly lush pasture, with very uneven topography including patches of subduction and some instances of protruding debris. Grid M6 contained a large amount of protruding debris including concrete blocks, scrap metal, piping and wooden posts at the boundary of Area D where the land slopes down toward the Wharekorino stream tributary. N6 had similarly exposed debris at the extent of Area D, near M6. Significant subsidence was observed at grid N7

M6 – concrete block, scrap metal, metal piping debris

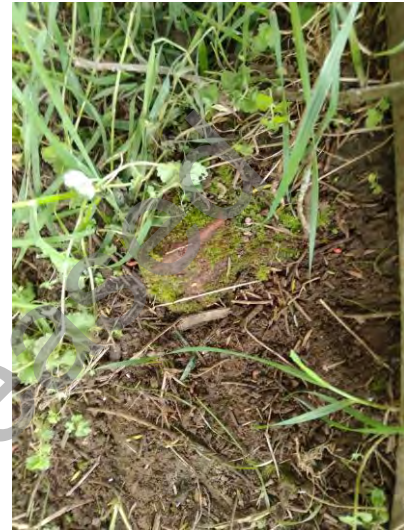
N6 – metal pipe protruding
