***Appendix B***

***Landfill Annual (2022) Walkover Survey Findings***

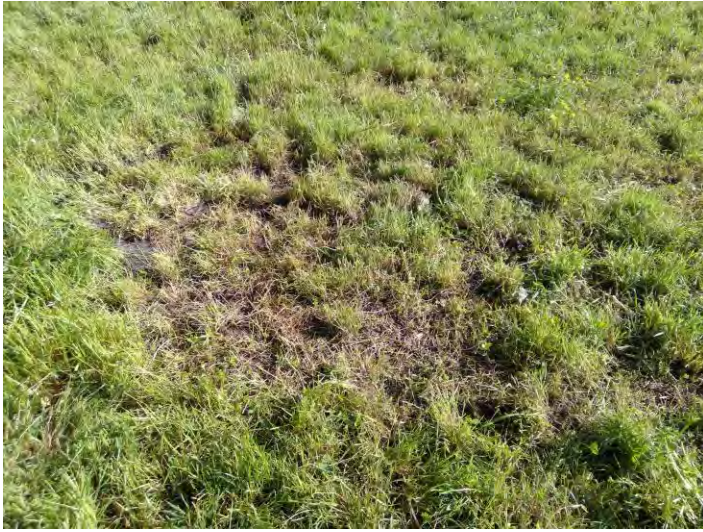
Patchy pasture was noted within grids B1, B2, and B3 stretching west through the extent of area A, and areas E4, E6, E7 and F6 along the northern boundary of Area A and southern boundary of Area B.

A1 – Patchy pasture

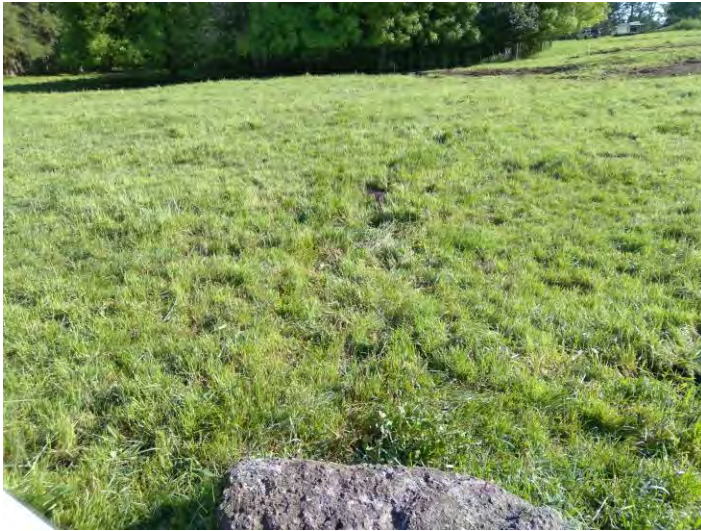
A3 – large cement block

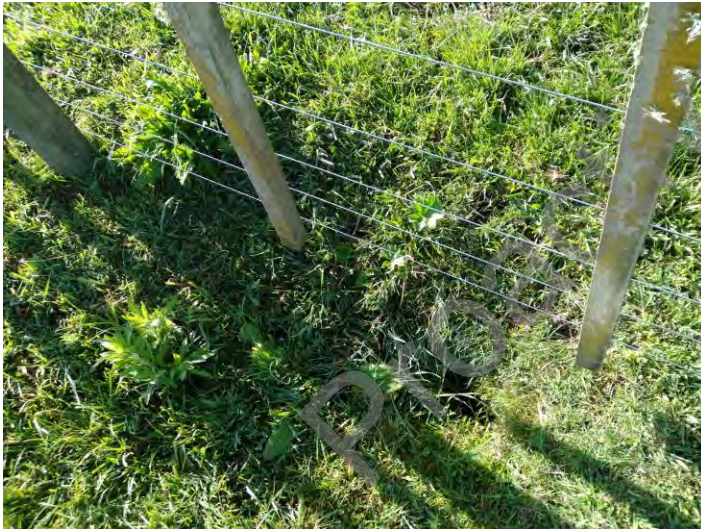
Ponding was observed at Grid D7, surrounding a permanent water trough. Subsidence/Erosion was visible at grid A3 at the fence line boundary.

A3 – Subsidence/erosion

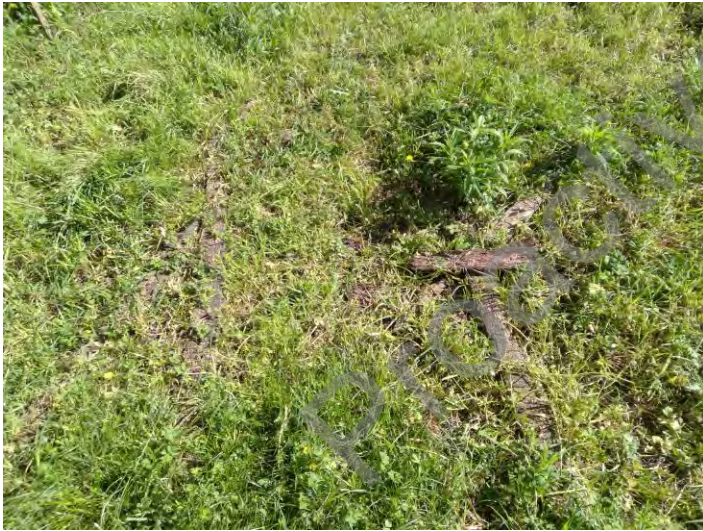
Protrusion of wooden posts and planks were visible at A1 and B1, which is reasonably far from the extent of the landfill in 1979, and at E4 at the edge of area A, which is more likely associated with filling activities. Cement blocks protrude at A1 and B1 which is reasonably far from the extent of Area A1 and likely dumped. They were also found protruding at A3, B4, D4, and E4 along the boundary fence line and western extent of Area A. 2 Ceramic posts were also noted to protrude at grid B3, at the extent of Area A.

B1 – wooden debris

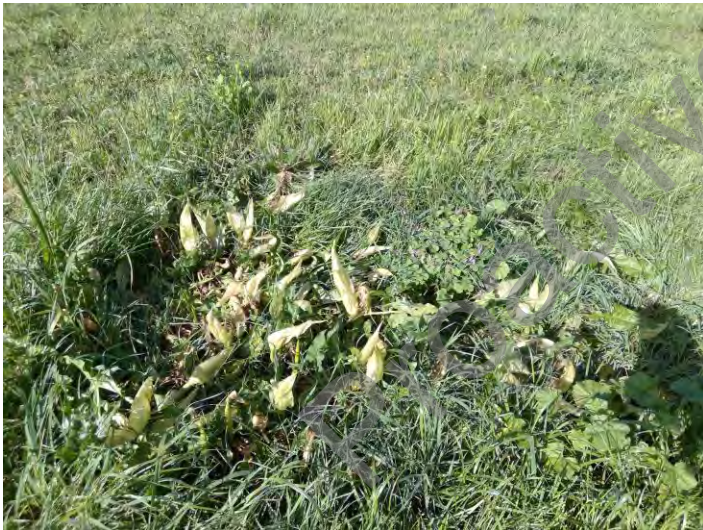
B2 – previous ponding

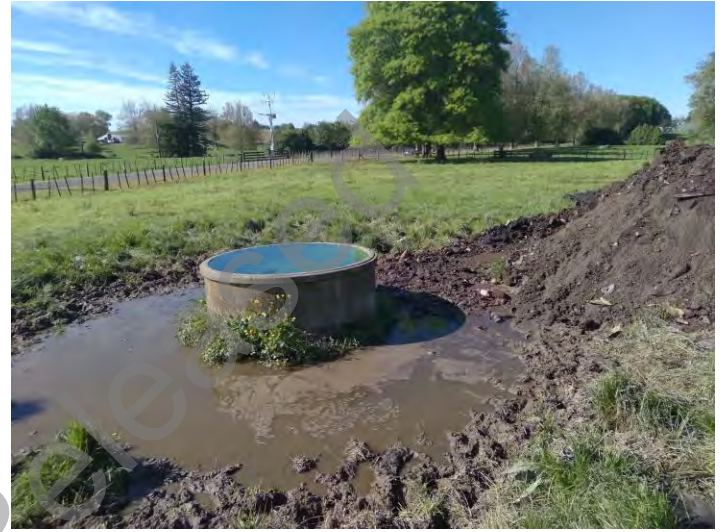
D7 – ponding

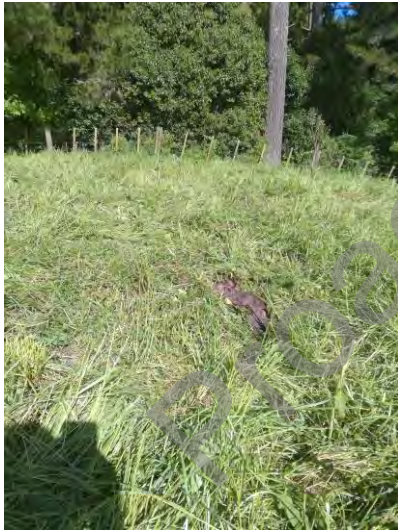
E4 - subsidence

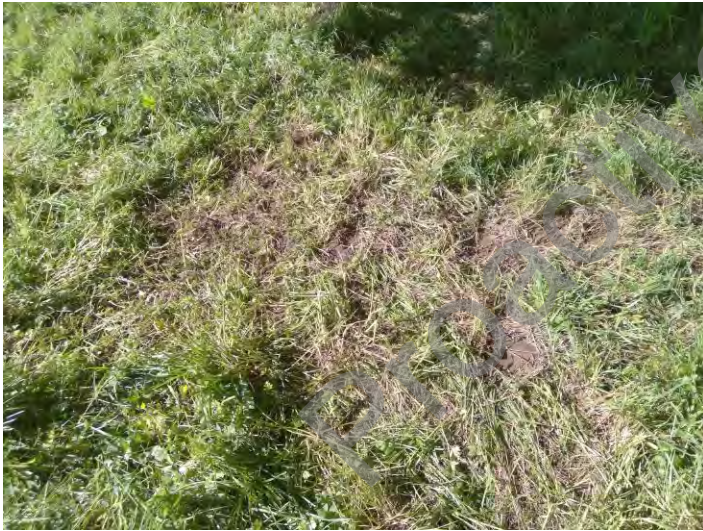
E4 – patchy pasture

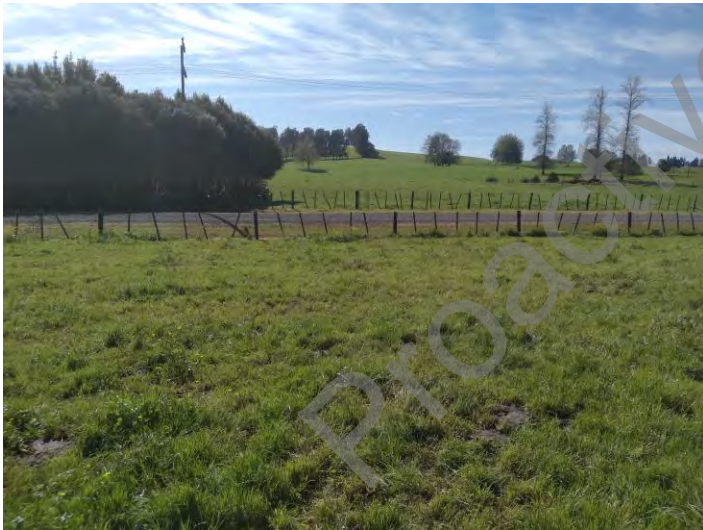
E7 – patchy pasture

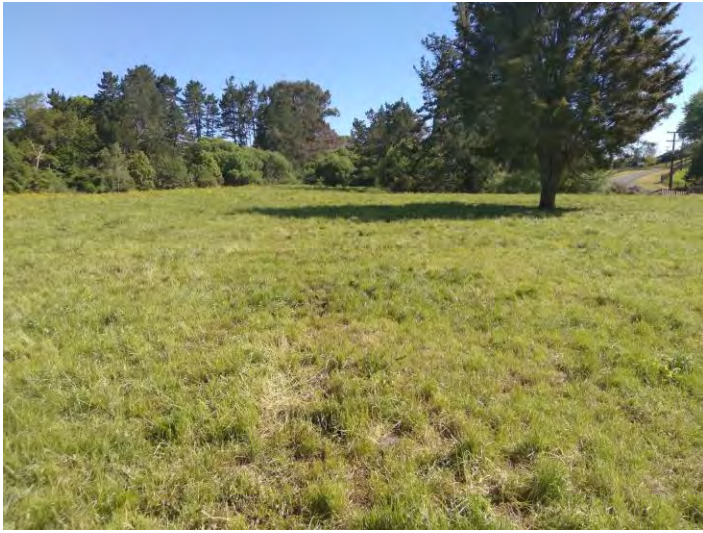
Area B: Area B was observed as having no features of note, and some minor localized instances of patchy pasture in grids F6 and G5.

F6 – patchy pasture

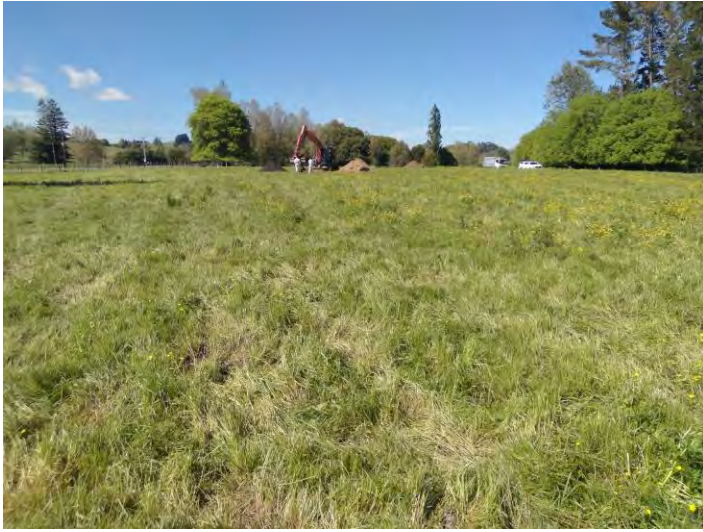
G5 – patchy pasture

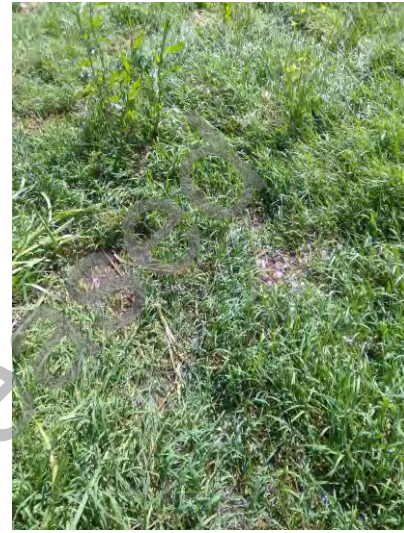
H4 – ponding extent

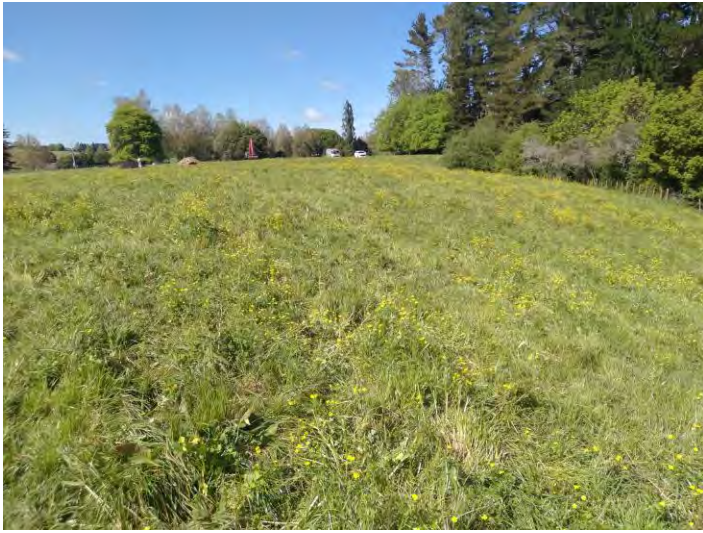
-	F7	
B	G4	
	G5	Patchy vegetation growth
	G6	-
-	G7	-
C	H4	Ponding at fence boundary
	H5	-
-	H6	Bricks, wooden post protruding
-	H7	Cement, wooden post protrusion
Extent of C	I4	-
	I5	Erosion, subduction at boundary fence

H4 – Ponding at fence boundary

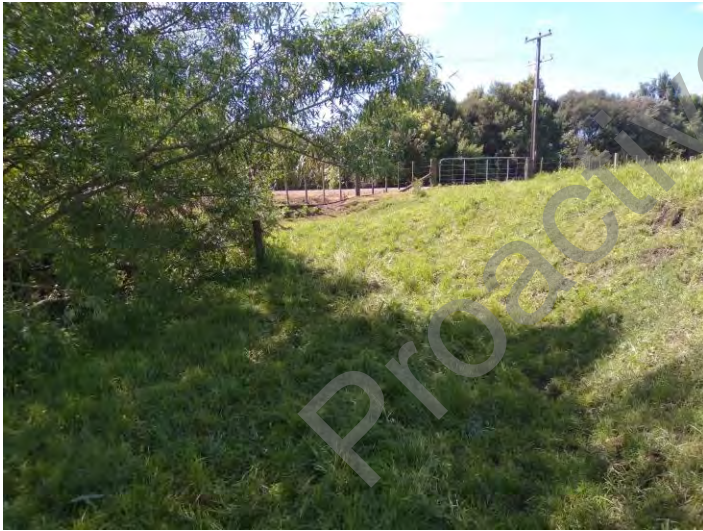
H6 – debris protruding

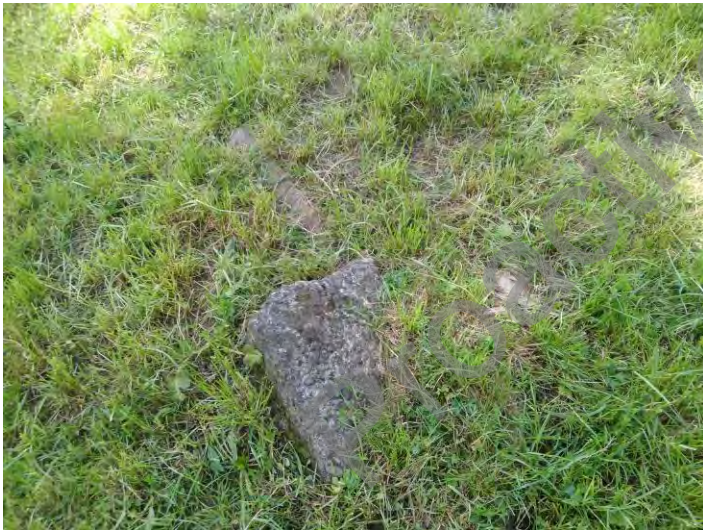
H7 – debris protruding

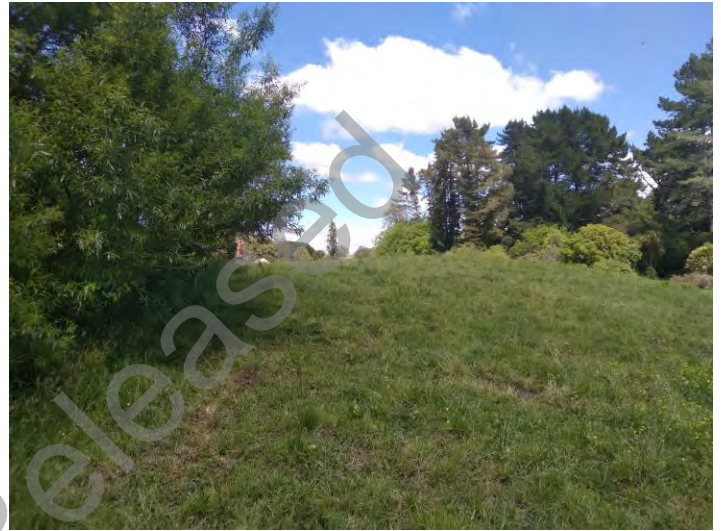
15 – erosion/subduction

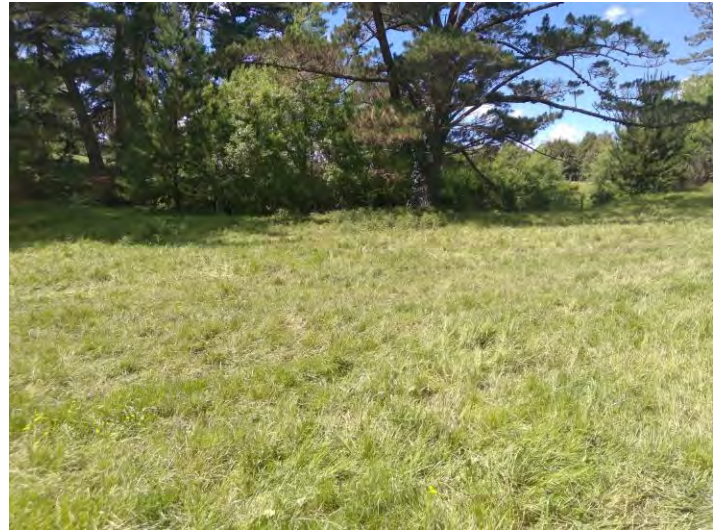
Area C: Area C was observed as mostly lush pasture, with large portions of ponding some visible subduction and subsidence. Grid J5 was the only portion of Area C where patchy pasture was observed, at the extent. Significant ponding was observed at H4 and minor ponding at K5, both located between the extent of area C and the Wharekorino stream. Ponding at both locations has been noted in previous years, and high stream flow is likely a large contributor. Localized subduction is observable at I5 at the extent of area near the fence line. Subsidence was noted at K6 at the north-eastern extent of area C.

J5 – patchy pasture

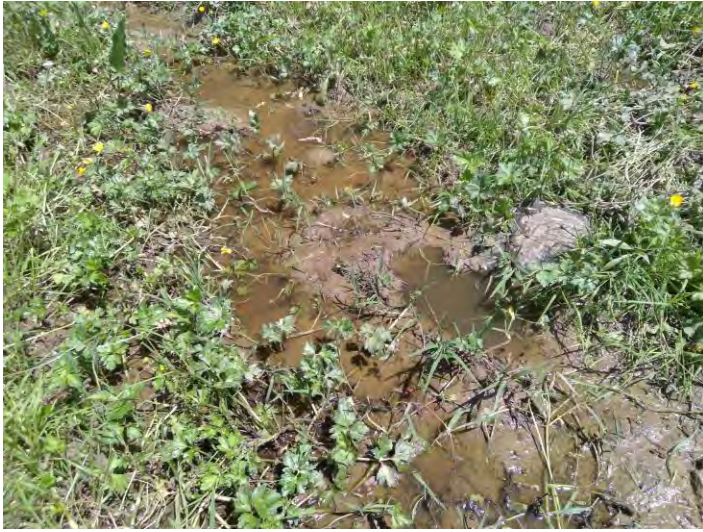
K4 - ponding

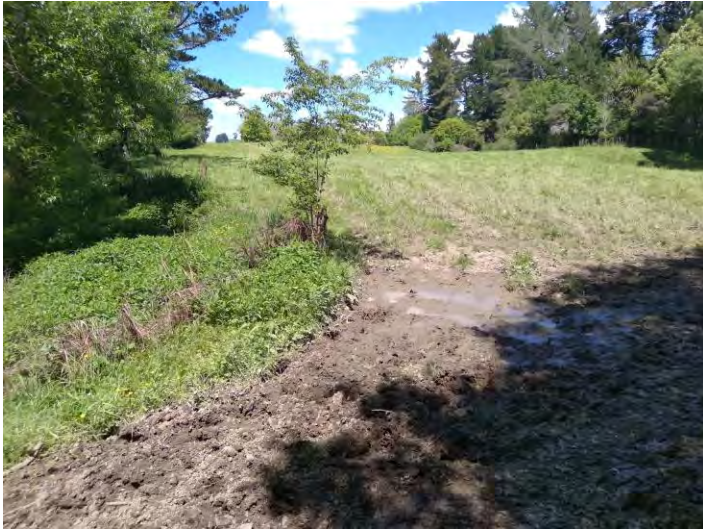
K5 - ponding

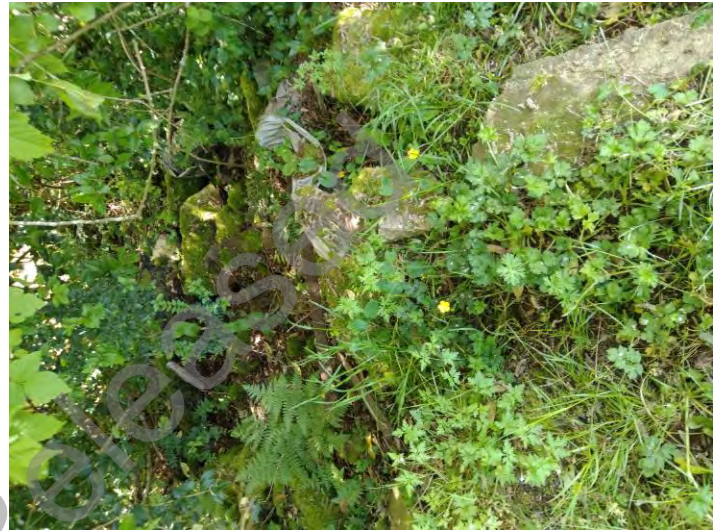
M6 – concrete debris

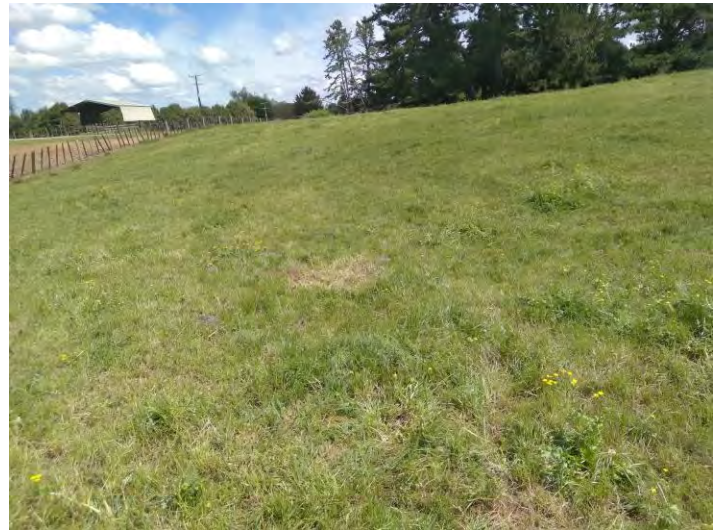
M9 – patchy pasture

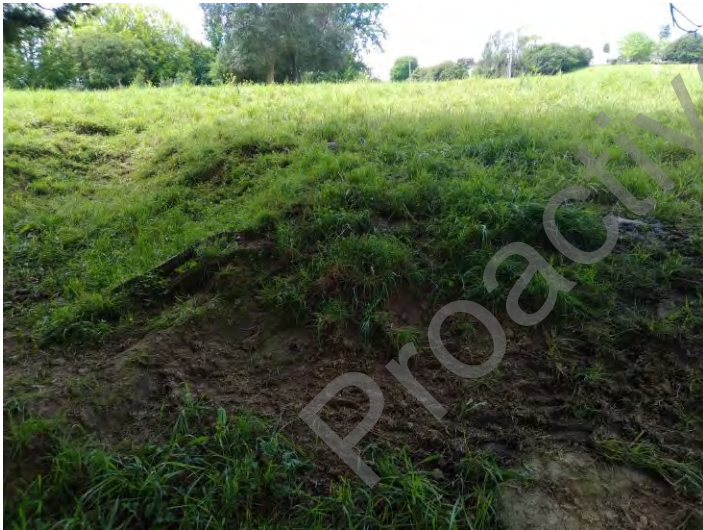
N6 – brick protruding

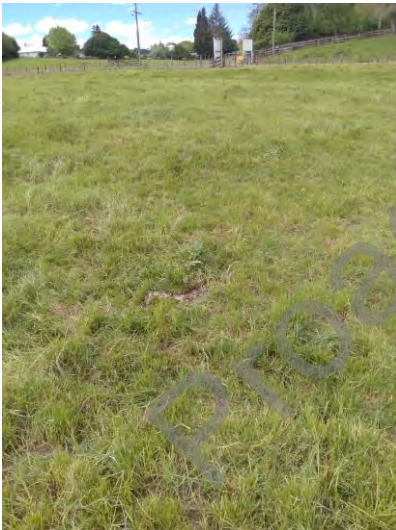
N7 – patchy pasture

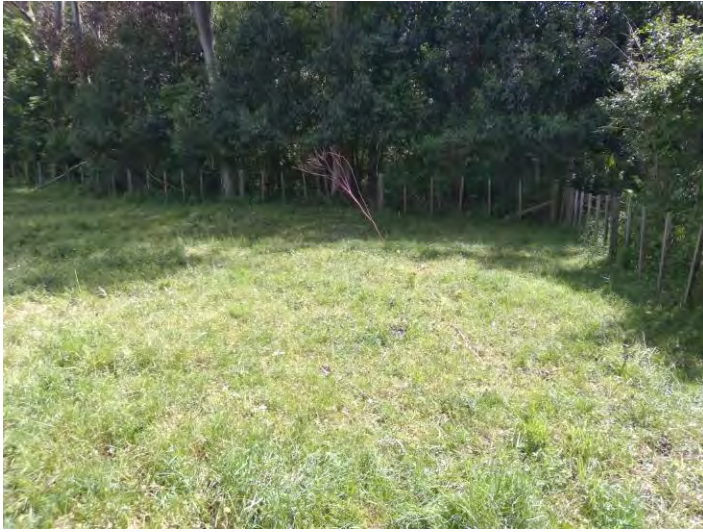
Area D: Area D was mostly lush pasture, with very uneven topography including patches of subduction and some instances of protruding debris. Grid M6 contained a large amount of protruding debris including concrete blocks, scrap metal, piping and wooden posts at the boundary of Area D where the land slopes down toward the Wharekorino stream tributary. N6 had similarly exposed debris at the extent of Area D, near M6. Significant subsidence was observed at grid N7

N7 - subsidence

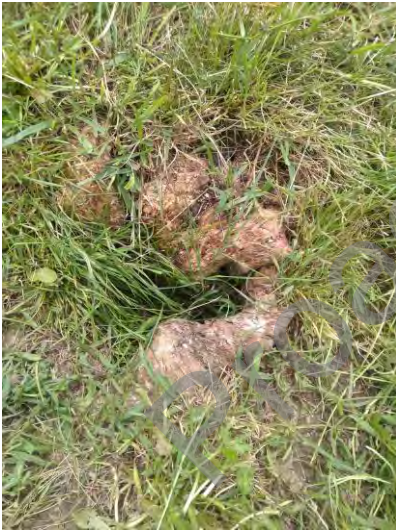
08 – stump protruding
